**LEISURE & AMENITIES COMMITTEE – 23 JUNE 2025****REPORT FOR INFORMATION****EXTERNAL PLAY AREA INSPECTION REPORTS**

# Safety Inspection Report

## Alexandra Play Park & Tennis Courts

Item 8(b) - Appendix 3  
**Alexandra Park  
 and Tennis Courts  
 Tree Safety  
 Survey 2025**

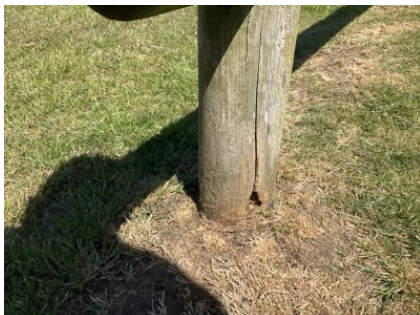
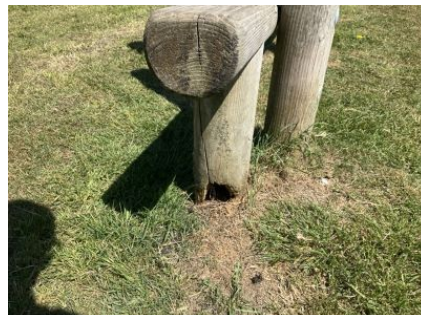
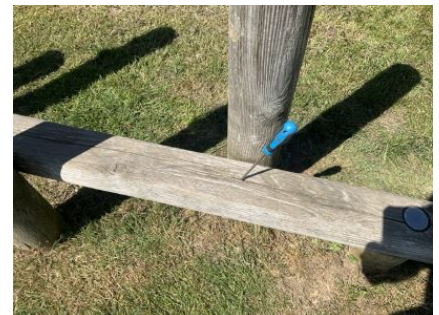
Strimmer damage and decay. Monitor stability and remove as worsens.

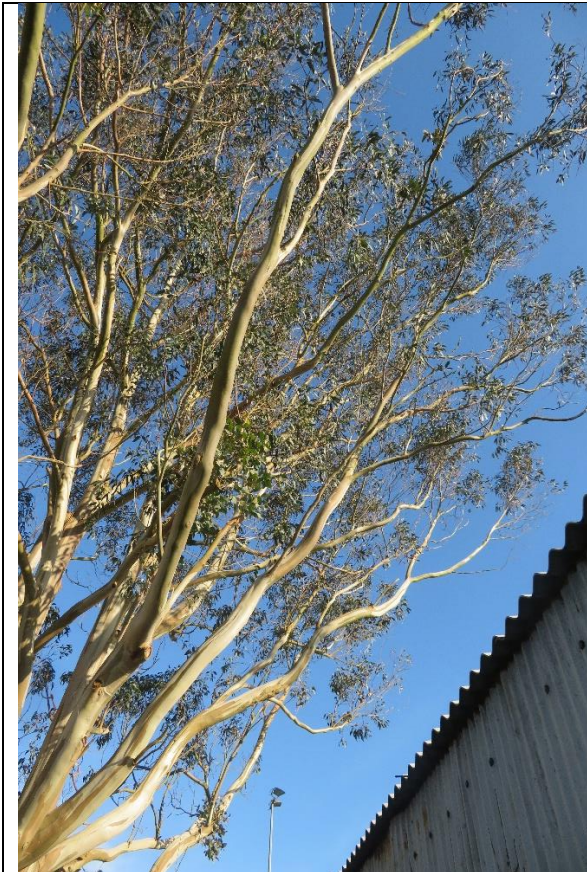
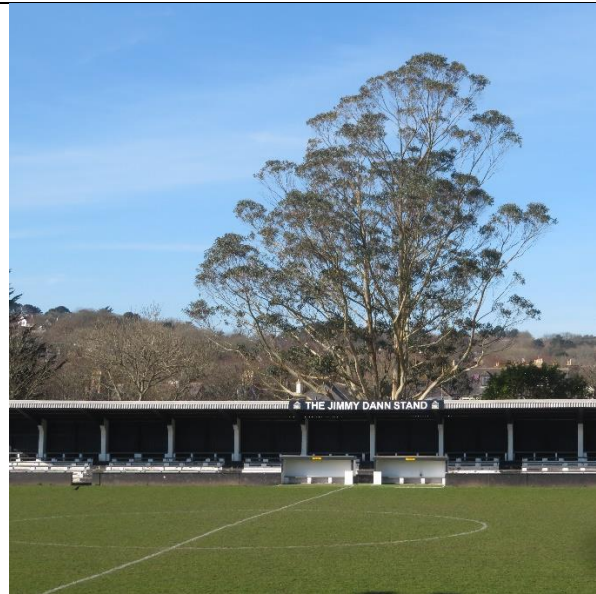
T1 Eucalyptus opposite and above. Remove deadwood of 25 mm or greater.

T2 Sycamore below.

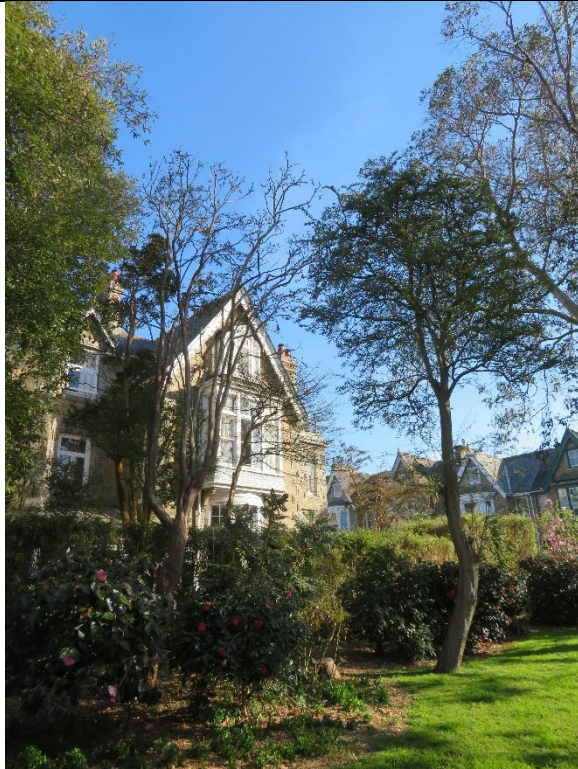
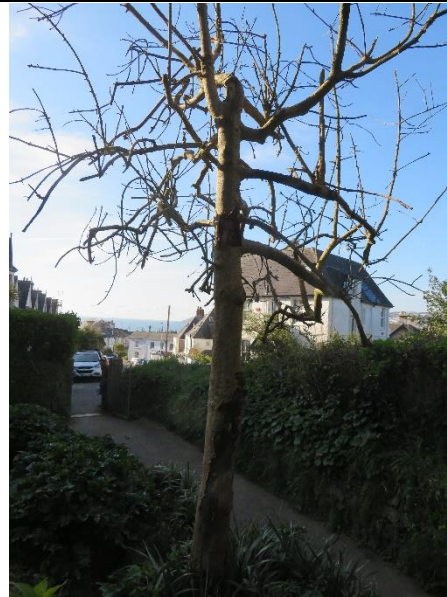
1871 Dead myrtle stem to left of centre in top right photo. Remove.

74 Dead Holly in photo above. Remove.

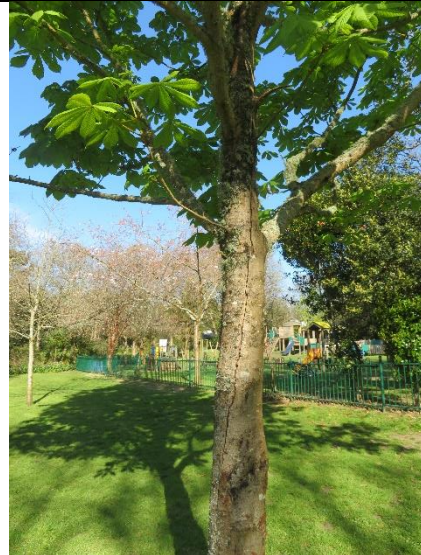
26 Horse Chestnut with torsion crack.

Monitor.

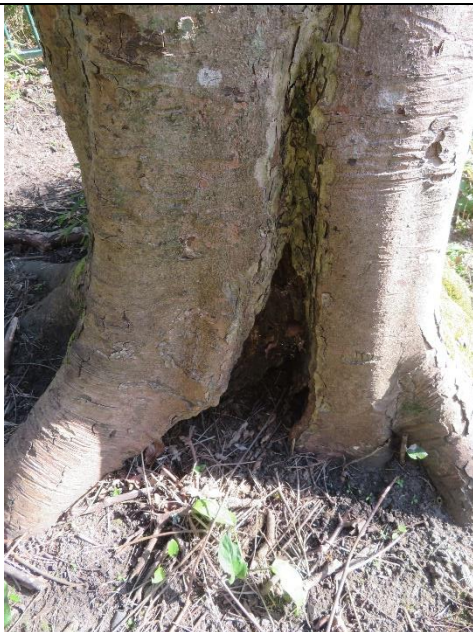
77 Sycamore with basal decay.

Monitor.

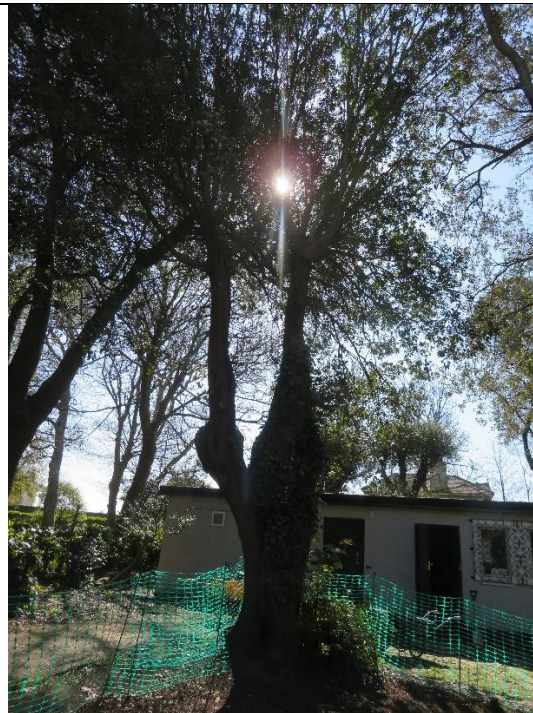
83 Ilex Oak. Squirrel damage to base of regrowth. Monitor.

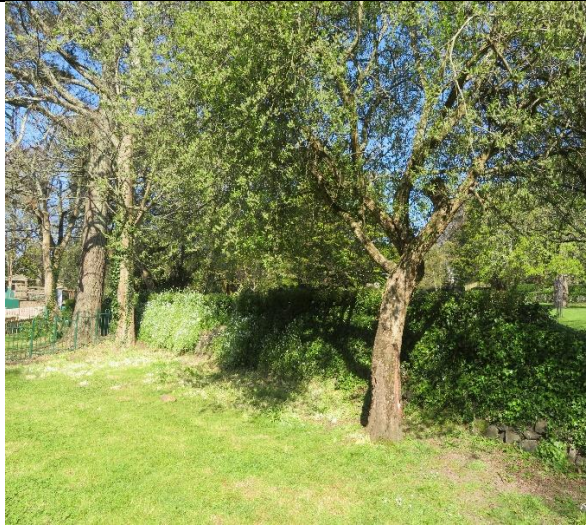
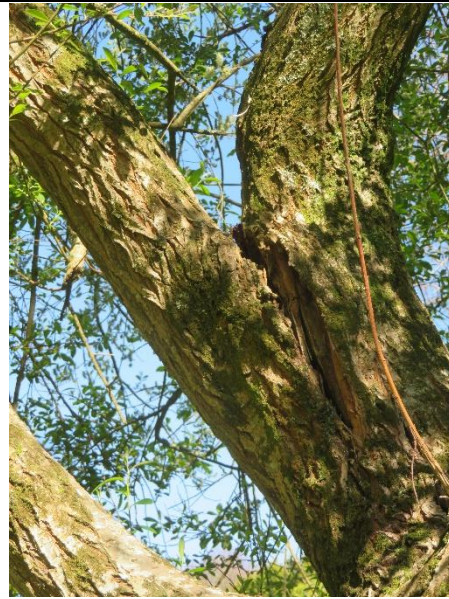
79 above and left Goat Willow. Monitor.

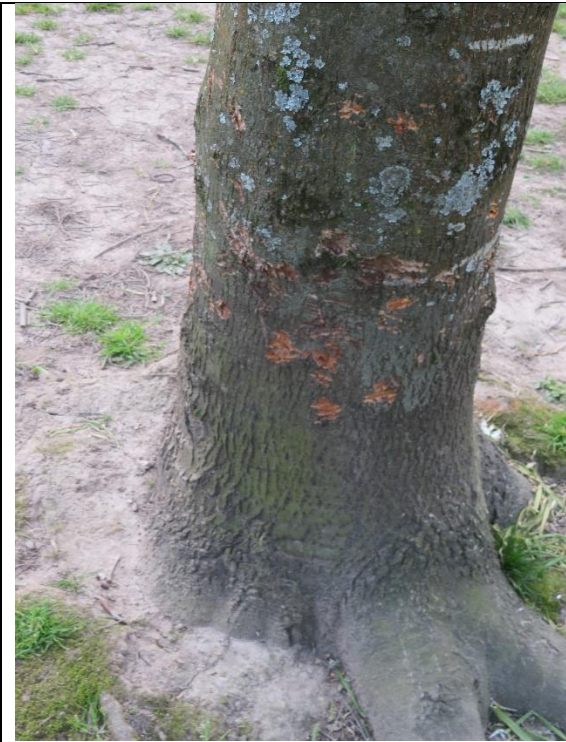
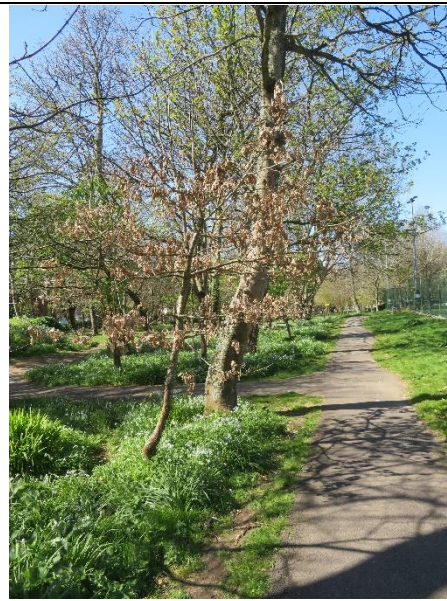
Extensive damage to lower stems of trees through park is typical in appearance to Muntjac deer damage.

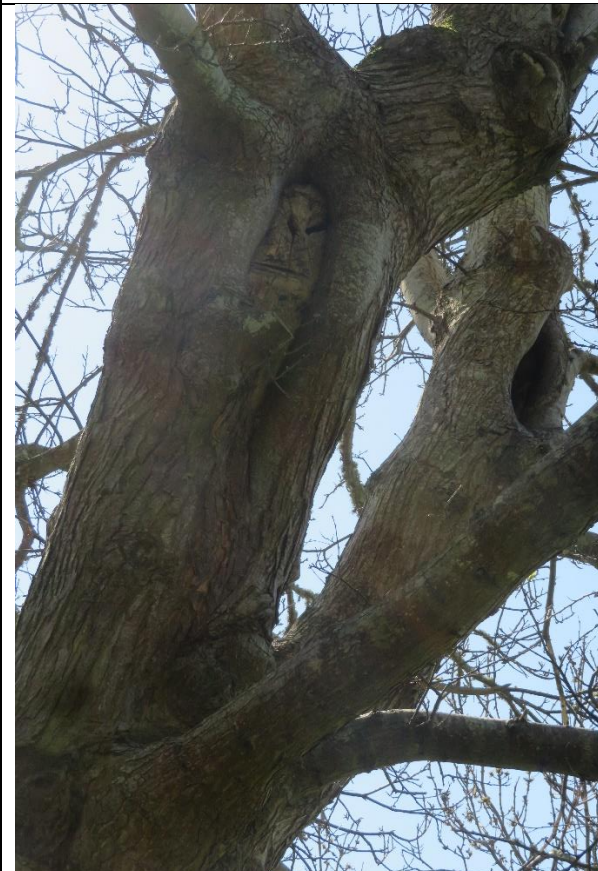
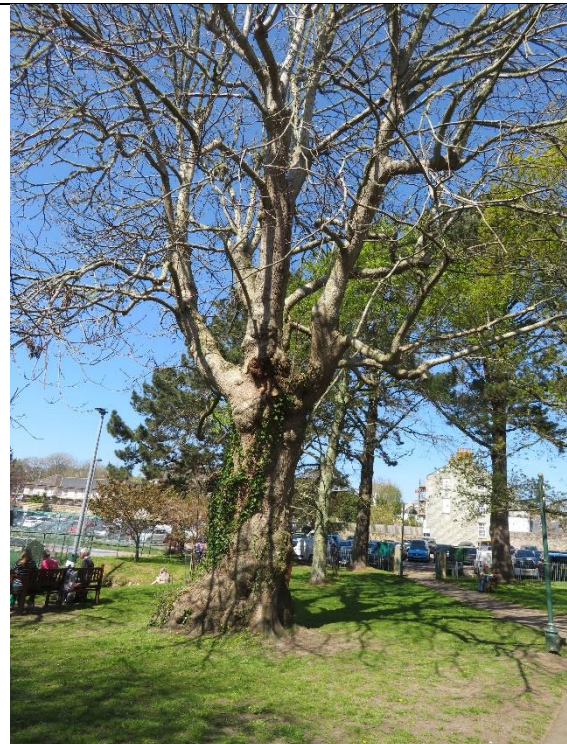
58 Sweet Chestnut. Monitor regrowth unions.

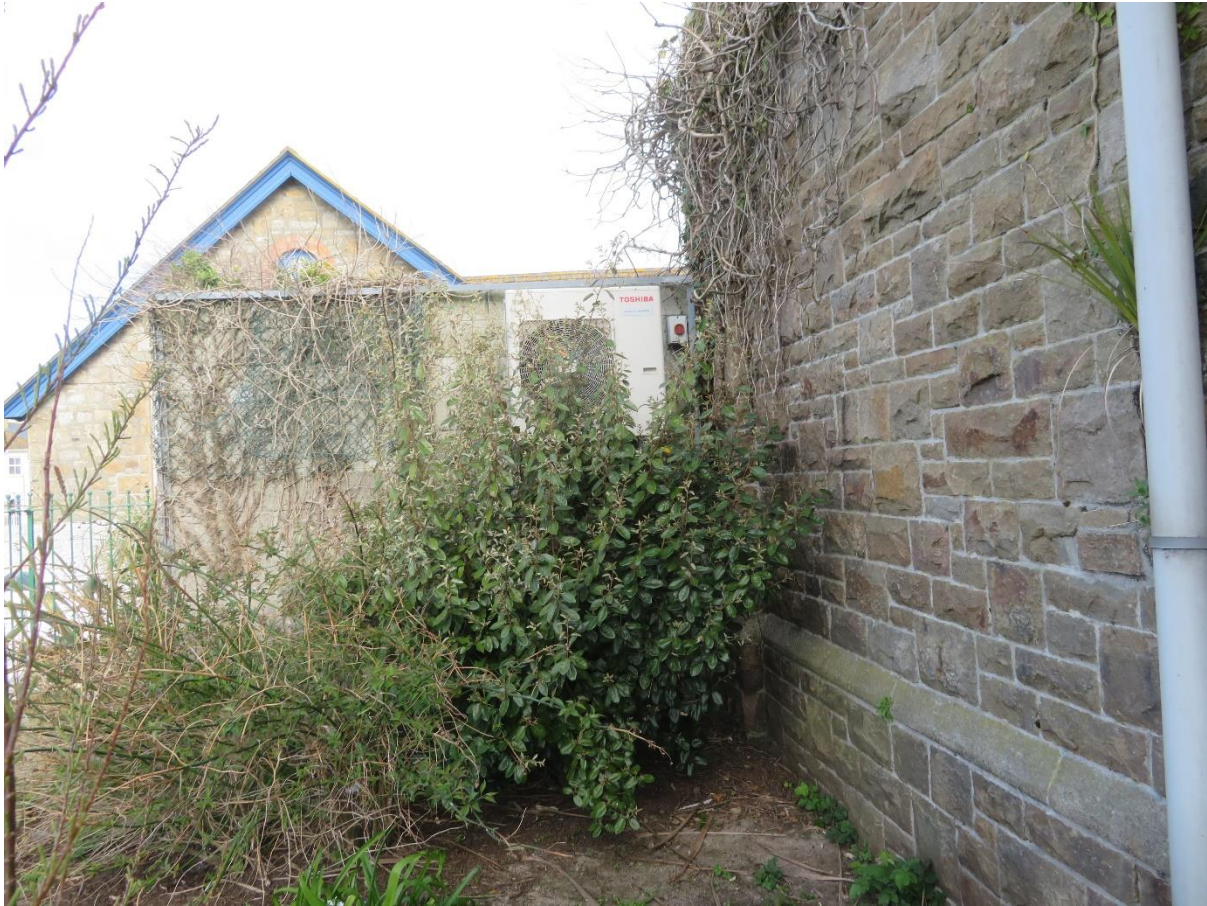
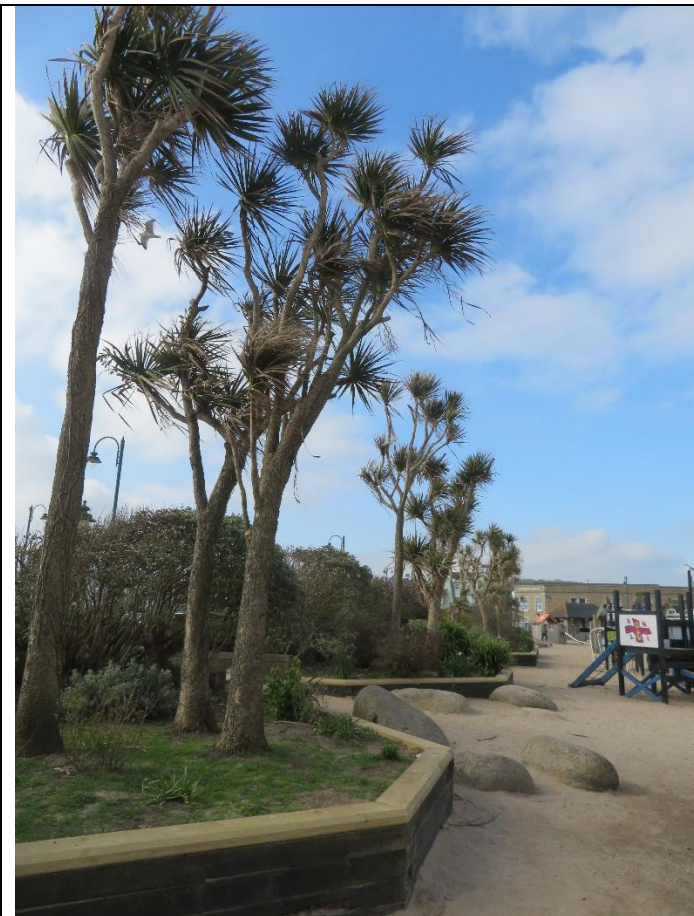
Above

Eleagnus by  
ventilation fan – trim  
clearance.

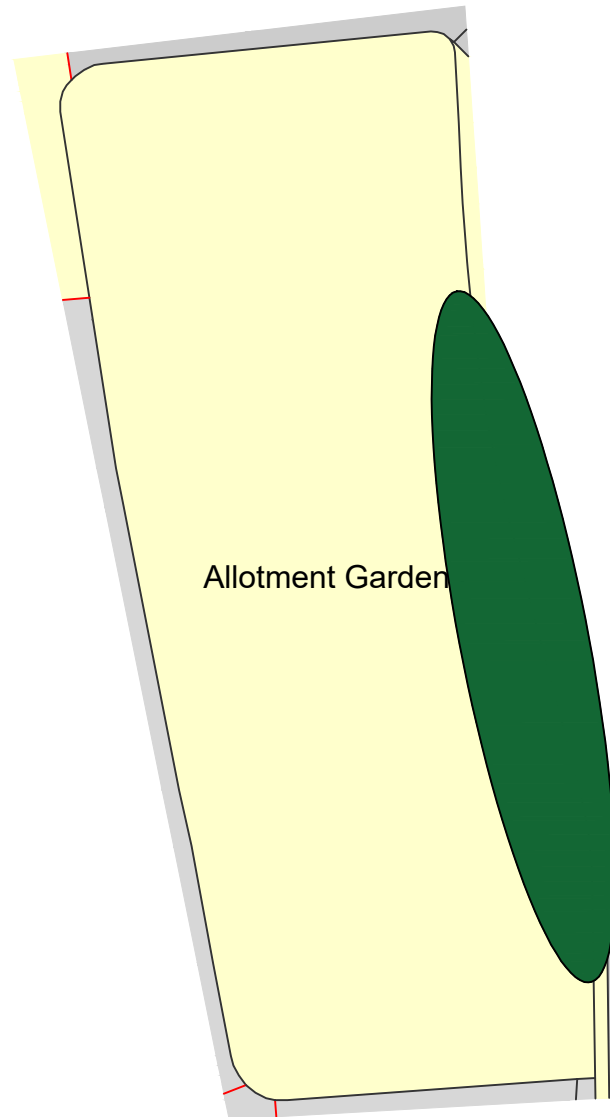
Mature  
trees  
mainly  
along  
eastern  
boundary.  
No  
works  
required.

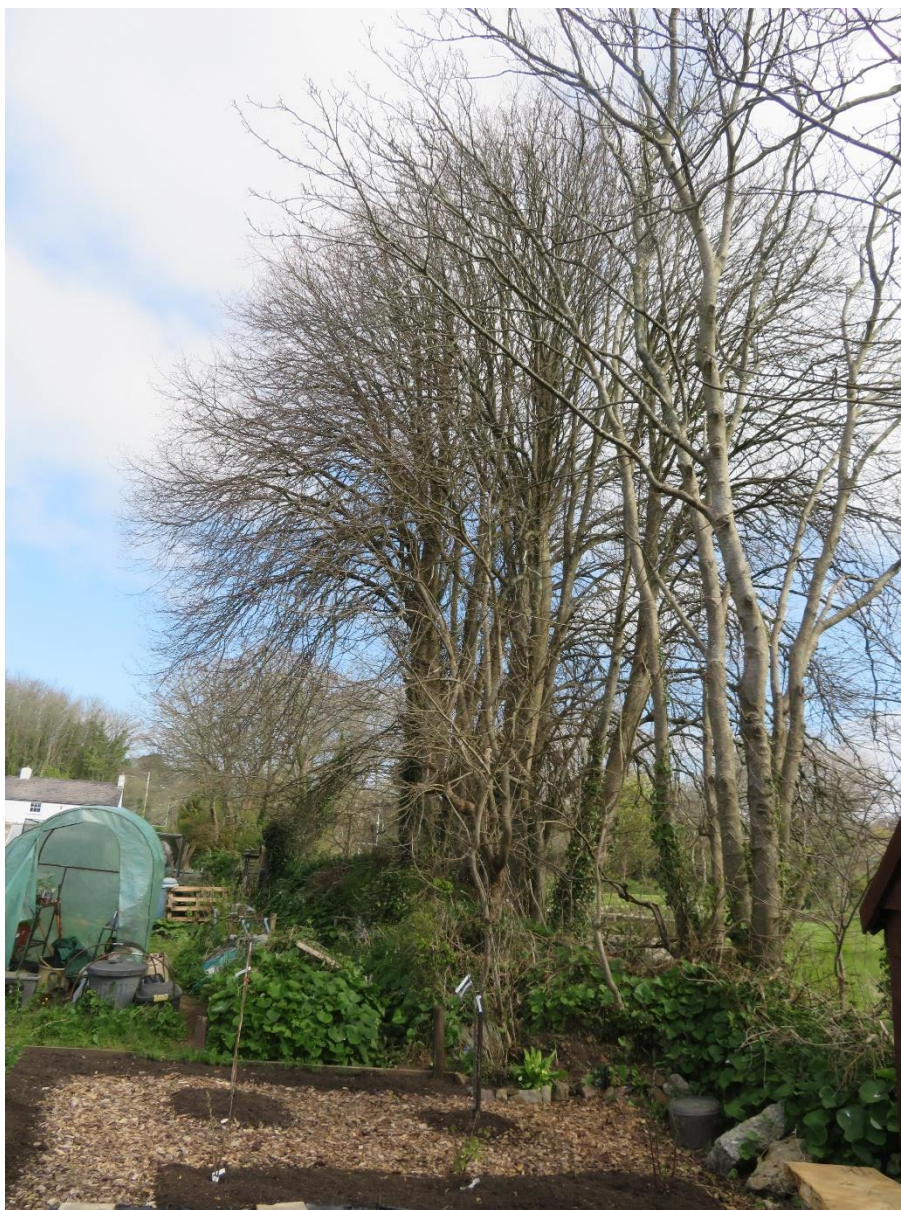
G1 Lime trees primarily. No works.

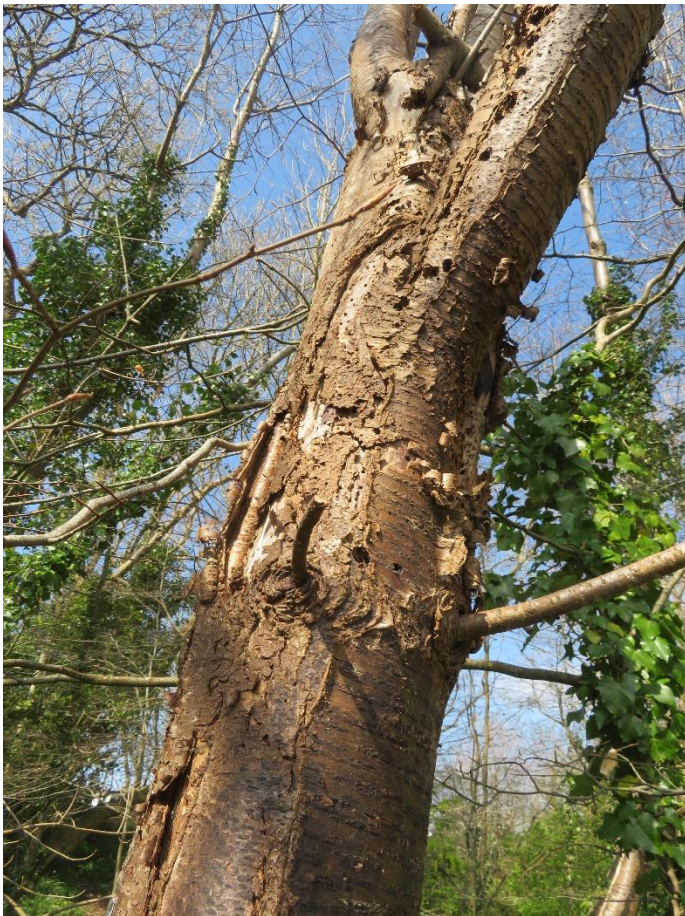
T89

Cherry with stem decay.

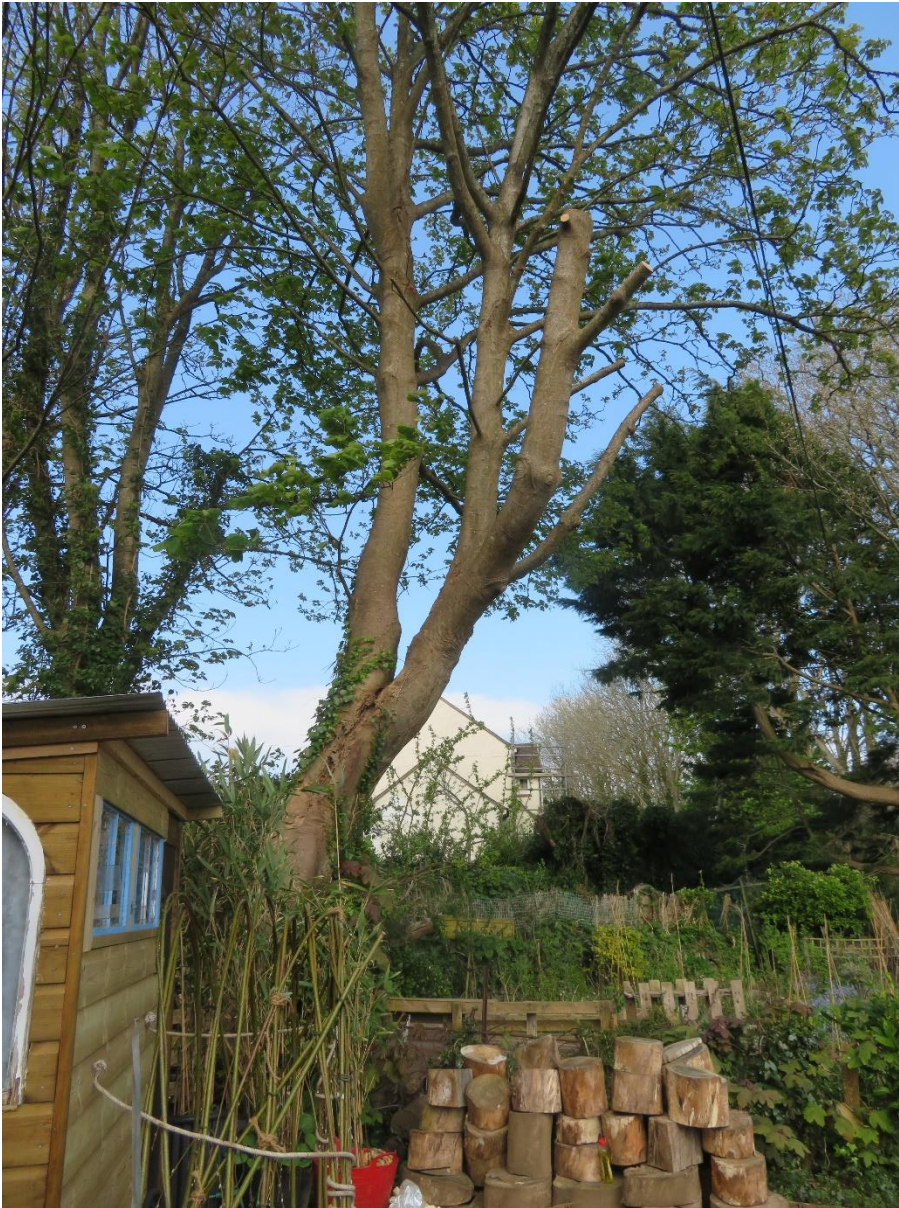
T812

Sycamore with recent heavy branch reduction.

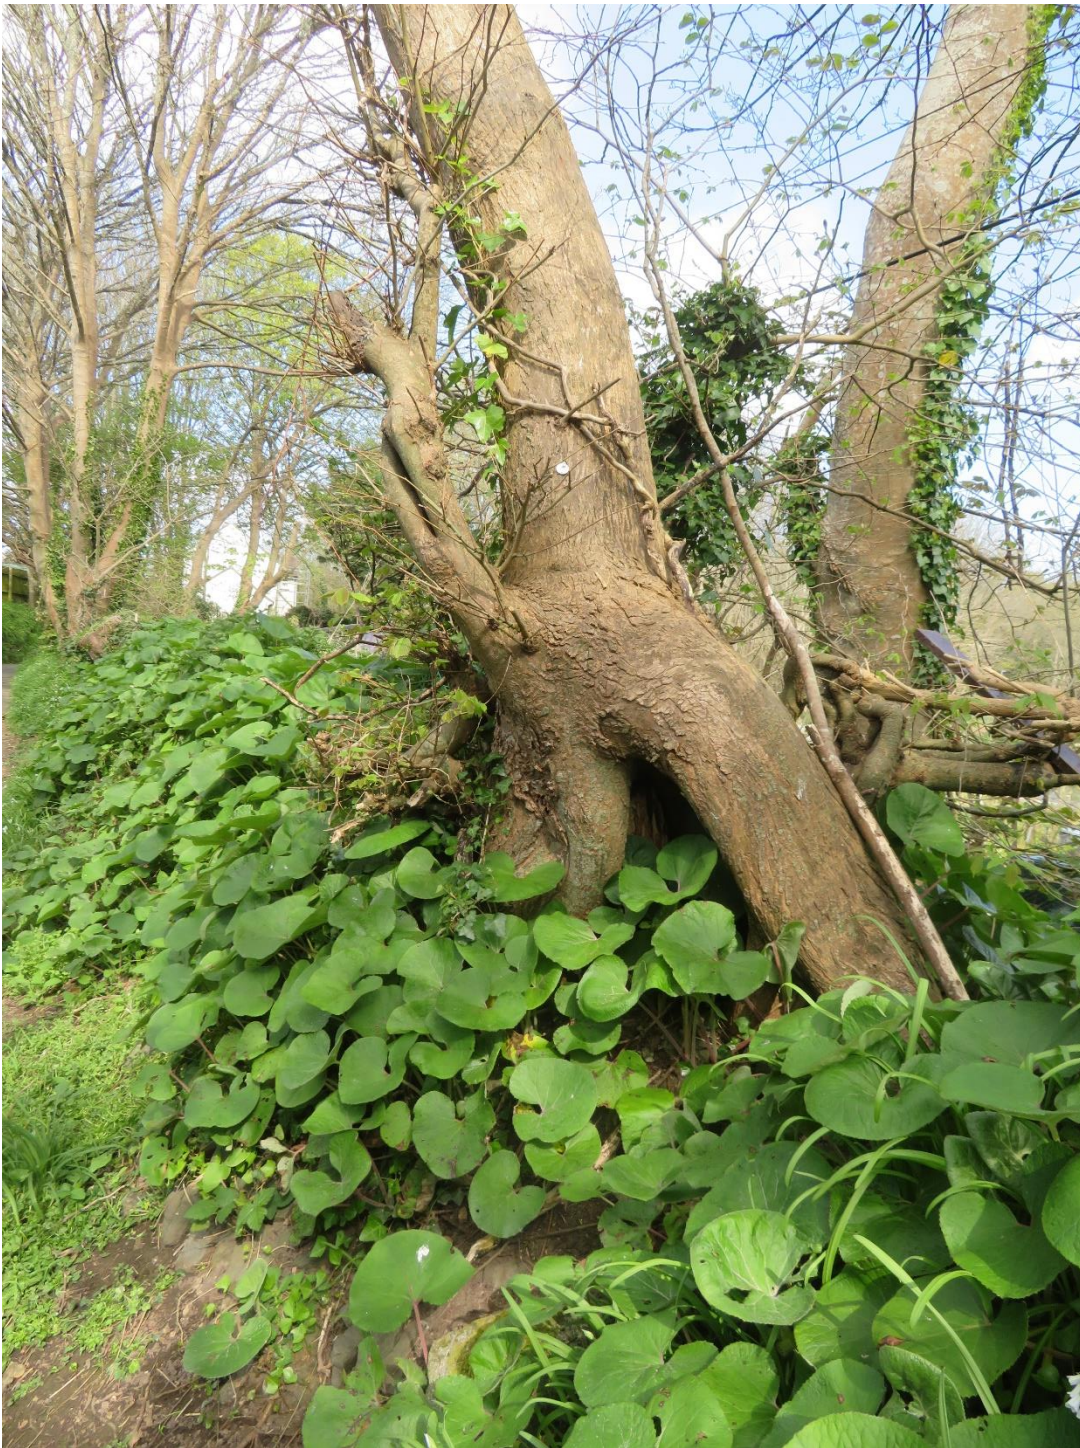
T1870

Elm with modified roots.

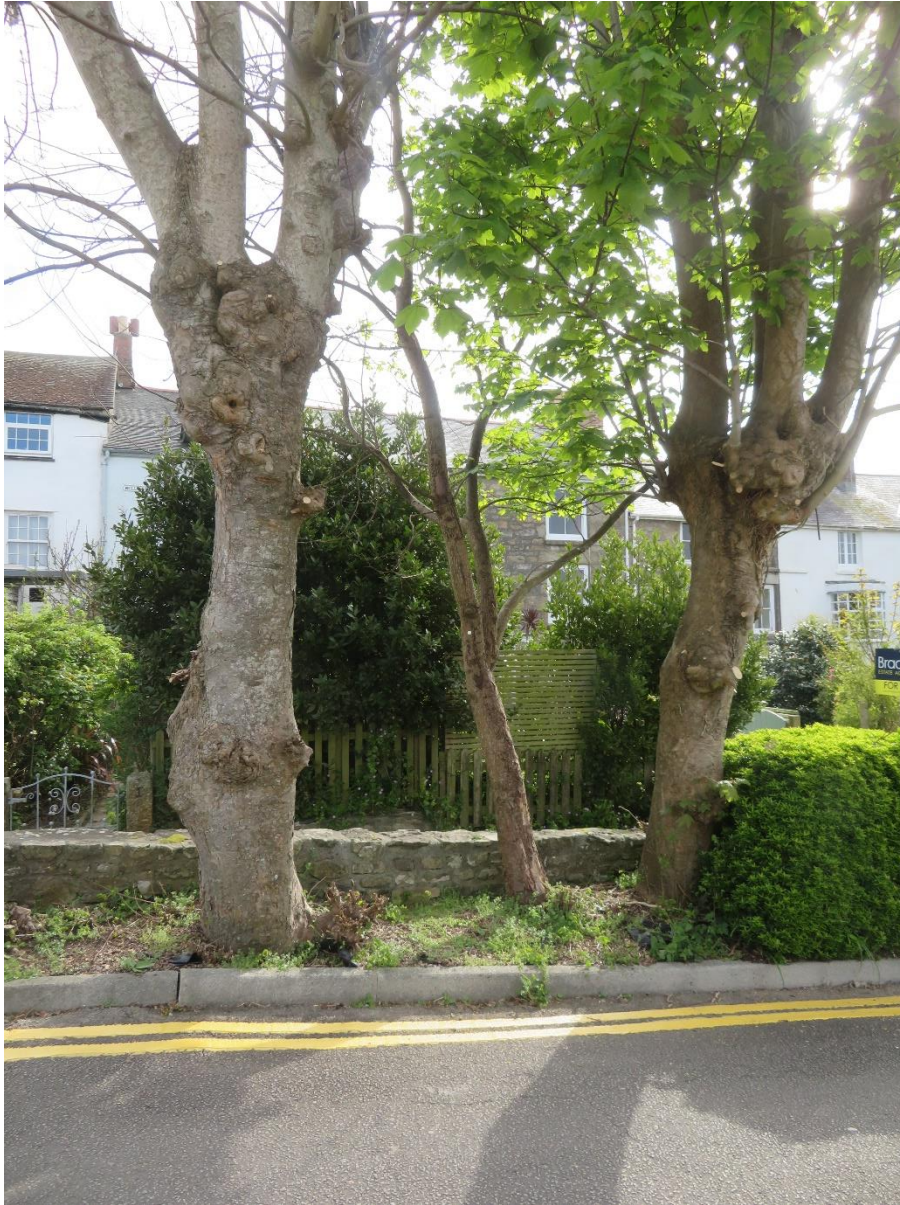
T84 Dead Elm between sycamore trees.
