**LEISURE & AMENITIES COMMITTEE – 11 AUGUST 2025****REPORT FOR INFORMATION****PENZANCE FOOTBALL CLUB WATER RISK ASSESSMENT 2025**

# LEGIONELLA RISK ASSESSMENT REVIEW

## PENZANCE AFC CLUB HOUSE

### Management of Water Hygiene Risk

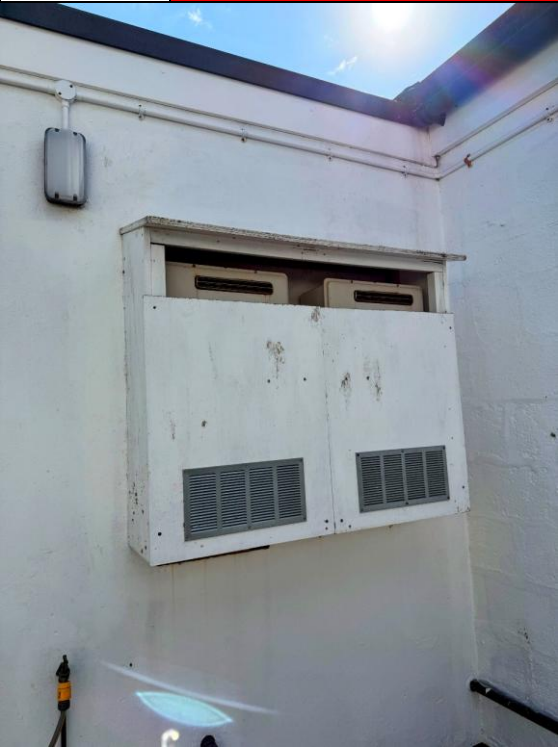
| ISSUE 1: FIRST IDENTIFIED IN 2021 RA | | GAS FIRED WATER HEATER 1 – FAULTY WATER HEATER | |
|---|---|---|---|
| | <p>Gas-fired water heater 1 (right side) is faulty and not heating water.</p> <p>For a 360 photo view of the location, click <a href="#">HERE</a>.</p> <p><b>Why It Matters:</b></p> <ul style="list-style-type: none"> <li>Only one of the two water heaters is in use, but the hot water pipes from both units are joined downstream. This allows water to stagnate in the inactive heater and its pipework, creating a potential breeding ground for Legionella.</li> </ul> <p>Since the systems are connected, bacteria from the stagnant leg could contaminate the main supply. Even if outlet temperatures were compliant, cooler water from the dormant pipework may mix in, reducing the effectiveness of temperature control. To minimise risk, the unused heater and its pipework should be isolated and drained or reinstated into full use.</p> | | <p>To reduce the risk of Legionella growth, there are two straightforward options.</p> <p><b>The first</b> is to get both water heaters working together, so hot water flows evenly through the system and no sections are left unused.</p> <p>If that's not possible right now, <b>the second option</b> is to fully isolate and drain the unused heater and its connected pipework. Importantly, at the point where the two hot water pipes join together, the disused pipe should be cut out of the system and capped off as close to the junction as possible. This prevents any stagnant water from remaining in a dead leg.</p> |

| ISSUE 1: FIRST IDENTIFIED IN 2021 RA | | GAS FIRED WATER HEATER 1 – FAULTY WATER HEATER | |
|---|---|---|---|
| Source for recommendations: | | <p>Temperature control is the traditional strategy for reducing the risk of legionella in water systems. Cold water systems should be maintained, where possible, at a temperature below 20 °C. Hot water should be stored at least at 60 °C and distributed so that it reaches a temperature of 50 °C within one minute at the outlets. [HSG 274 Part 2, 2.6].</p> <p>TMV valves should be as close to the POU as possible to minimise the storage of blended water" [HSG 274 Part 2, 2.76].</p> | |

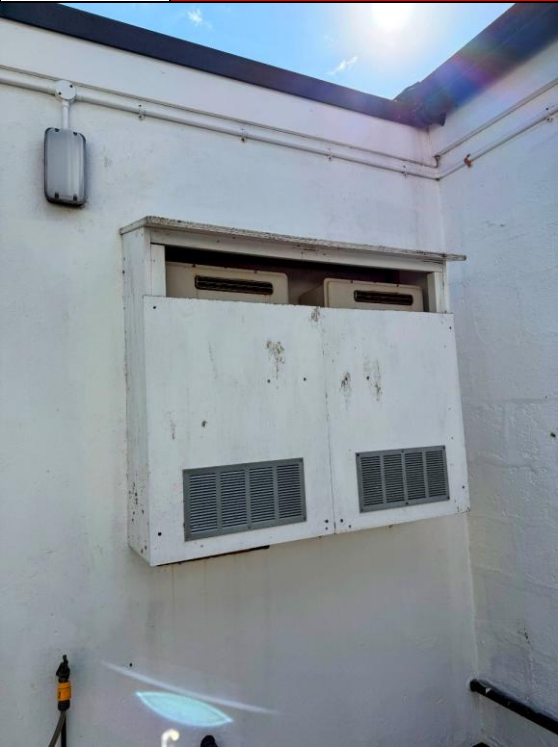
| ISSUE 2: <b>FIRST IDENTIFIED IN 2021 RA</b> | | <b>GAS FIRED WATER HEATER 2 – LOW HOT WATER TEMPERATURE</b> | |
|---|---|---|---|
| | <p>Gas-fired water heater 2 (left side) is only operating at 42°C</p> <p><u>For a 360 photo view of the location, click <a href="#">HERE</a>.</u></p> <p><b>Why It Matters:</b></p> <ul style="list-style-type: none"> <li>The showers at the clubhouse are supplied by instantaneous water heaters set to deliver water at 42 °C. While this type of system avoids storing hot water, reducing the risk of stagnation, it doesn't remove the risk of Legionella, especially because showers produce fine water droplets (aerosols) that can be breathed in.</li> </ul> <p>Legionella bacteria grow best in water between 20 °C and 45 °C. Since the hot water is set to 42 °C, it's within that risk range. Normally, systems are designed to store hot water at 60 °C and deliver it at 50 °C or higher to help control bacteria. That's not happening here, likely because there are no thermostatic mixing valves (TMVs) to prevent scalding, so the temperature has been turned down at the heater instead.</p> | | <p>The most effective solution is to increase the water heater temperature and install thermostatic mixing valves (TMVs) at each outlet. These valves safely mix hot and cold water just before it's used, allowing the system to operate at higher temperatures (around 60 °C) to control Legionella, while delivering safe temperatures at the taps and showers.</p> <p>Each shower should have a TMV fitted as close as possible to the outlet, and every hand wash basin needs its own TMV.</p> <p><b>As an interim measure</b>, a weekly thermal disinfection routine can be used while waiting for TMVs to be installed. This involves raising water heater temperatures to at least 60 °C and flushing all hot outlets, especially showers, until the outlet temperature reaches 60 °C for 7 minutes. While this may temporarily reduce Legionella levels, it is not a long-term substitute for proper temperature control through a compliant system design and should only be used as an interim measure..</p> |

| ISSUE 2: <b>FIRST IDENTIFIED IN 2021 RA</b> | | <b>GAS FIRED WATER HEATER 2 – LOW HOT WATER TEMPERATURE</b> | |
|---|---|---|---|
| <b>Source for recommendations:</b> | | <p><i>Stagnation can lead to conditions which encourage the growth of biofilm and legionella. To reduce the risk, outlets on hot and cold water systems should be used at least once a week to maintain a degree of water flow and minimise the chances of stagnation." (HSG274 Part 2, para 2.50)</i></p> | |

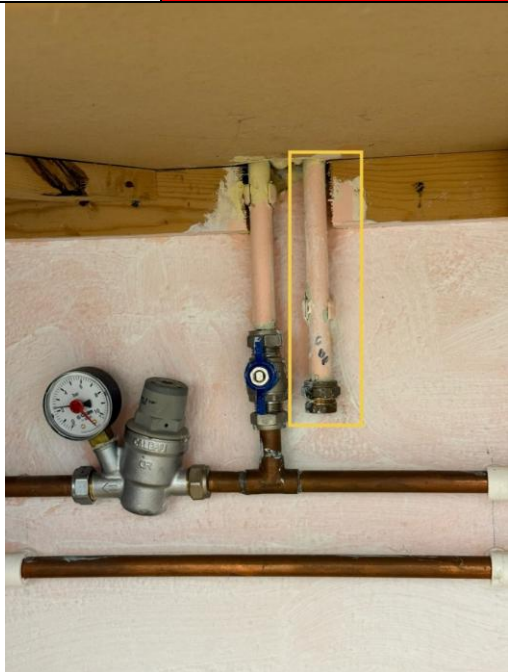
| ISSUE 3: <b>FIRST IDENTIFIED IN 2021 RA</b> | | <b>FEMALE TOILET – DEAD LEG OF PIPE (NEXT TO WATER HEATER)</b> | |
|---|--|---|---|
| | | <p>There is a capped-off water pipe (from an unknown source) that protrudes from the ceiling above. This pipe may be a hot water pipe that previously served the basins.</p> <p>For a 360 photo view of the location, click <a href="#">HERE</a>.</p> <p><b>Why It Matters:</b></p> <ul style="list-style-type: none"> <li>• This capped-off dead leg can create a significant risk for Legionella bacteria, especially if it was originally part of the hot water system.</li> <li>• Stagnant water: Once a pipe is capped and unused, water inside it no longer circulates. If the pipe previously carried hot water, residual warmth in the pipe (particularly within the 20–45 °C range) can support bacterial growth.</li> <li>• Hidden and unflushed: Because the pipe is now isolated, it's not flushed during normal use, so any bacteria or biofilm inside can thrive undisturbed.</li> <li>• Potential reintroduction: If the dead leg is ever accidentally reconnected or backflow occurs (e.g. from nearby pressure fluctuations), it could contaminate the live water system.</li> </ul> | <p>The dead leg should be cut back to the nearest live branch in the system. It's important to trace the origin of the capped pipework—if it was previously part of the hot water supply (e.g. to a shower), the risk is higher due to the potential for warm stagnant water.</p> <p>Simply leaving the pipe capped and unused allows water to sit undisturbed, which encourages bacterial growth. Removing the redundant section altogether ensures there's no hidden stagnation point.</p> |

| ISSUE 3: <b>FIRST IDENTIFIED IN 2021 RA</b> | | <b>FEMALE TOILET – DEAD LEG OF PIPE (NEXT TO WATER HEATER)</b> | |
|---|--|---|---|
| <b>Source for recommendations:</b> | | <p><i>Stagnation can lead to conditions which encourage the growth of biofilm and legionella. To reduce the risk, outlets on hot and cold water systems should be used at least once a week to maintain a degree of water flow and minimise the chances of stagnation." (HSG274 Part 2, para 2.50)</i></p> | |

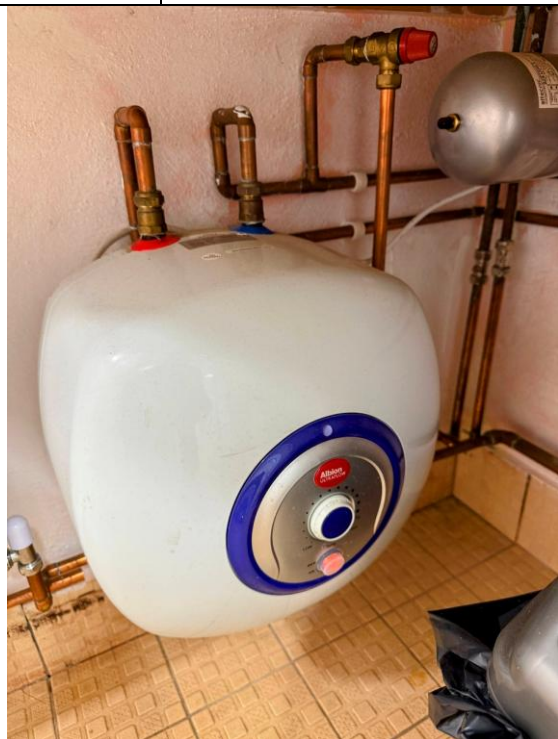
| ISSUE 5: MALE & FEMALE TOILET WATER HEATERS – LOW HOT WATER TEMPERATURE | |
|---|---|
| | <b>ISSUE</b><br><p>Both water heaters are only operating at 41 and 42°C, respectively.</p> <p><b>Why It Matters:</b></p> <ul style="list-style-type: none"> <li>Both POU water heaters are supplying water at 41 °C and 42 °C, which is not hot enough to control the growth of Legionella bacteria. This temperature range is ideal for bacterial proliferation and falls below the recommended minimum of 50 °C at outlets used for control purposes. Because these units are small (10 litres) and located close to the outlets, they lack a long distribution system, but the risk still exists, especially if water sits unused for long periods, or if the heaters cycle on and off at low temperatures.</li> <li>The hand wash basins are used by a wide range of building users, including those with disabilities, some of whom may be more vulnerable to infection. This increases the importance of maintaining safe water temperatures as part of a broader duty of care.</li> </ul> |

| ISSUE 5: MALE & FEMALE TOILET WATER HEATERS – LOW HOT WATER TEMPERATURE | |
|---|---|
| | <b>SOLUTION</b><br><p>The best approach is to raise the temperature settings on both point-of-use (POU) water heaters so that water reaches at least 50 °C at the outlet.</p> <p>To prevent the risk of scalding, particularly as the basins are used by potentially vulnerable users, including those with disabilities, install thermostatic mixing valves (TMVs) to each water heater. These will safely blend the hot water down to a suitable handwashing temperature (typically around 41 °C), while still allowing the POU heaters to operate at temperatures that help control bacterial growth.</p> <p><b>Interim Control (short term)</b></p> <p><i>Run each hot tap daily until the hot water is cold to reduce stagnation and flush through any low-temperature water.</i></p> |
| <b>Source for recommendations:</b> | <p><i>Low storage volume heaters serving hot water outlets should be able to achieve a peak temperature of 50–60 °C and where the thermostat is set at these temperatures for this purpose, staff and other users should be informed not to adjust the heater. A unit which is not capable of achieving this, eg a preset thermostat, should only be used where there is a very high turnover or an alternative control measure is in place. (HSG274 Part 2, para 2.69)</i></p> <p><i>Where there are vulnerable people present (eg the very young, elderly or disabled), additional care should be taken to ensure that hot water outlets do not present a scalding risk. Thermostatic mixing valves (TMVs) or other appropriate temperature control devices should be fitted and maintained to ensure safe outlet temperatures. (HSG274 Part 2, para 2.56)</i></p> |

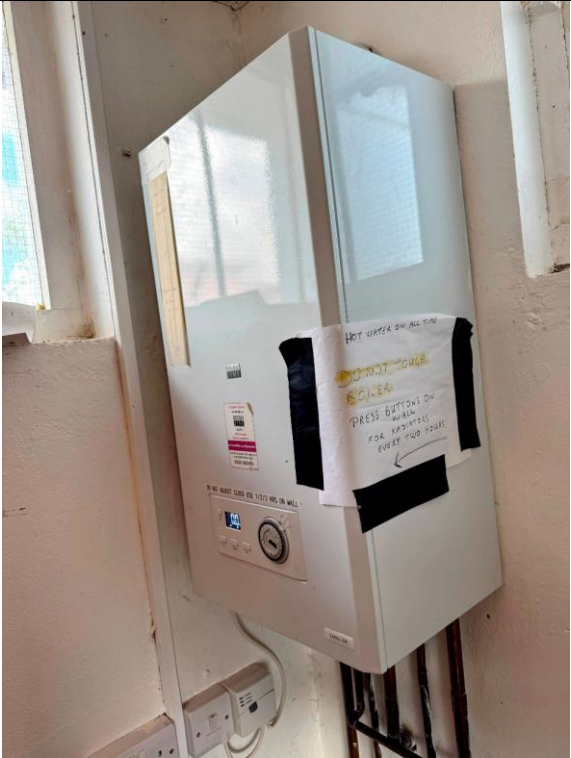
| ISSUE 6: | COMBI BOILER (STORE ROOM 1) – NOT HEATING WATER | | |
|---|---|---|--|
| | <p>The Combi Boiler is not heating water.</p> <p>For a 360 photo view of the location, click <a href="#">HERE</a>.</p> <p><b>Why It Matters:</b></p> <ul style="list-style-type: none"> <li>The gas-fired combi boiler supplying hot water to the bar kitchen is not currently heating water, although flow is still present. This poses a concern for Legionella control because the water temperature remains within the ideal growth range (20–45 °C). Without sufficient heating (minimum 50 °C at outlets), the system cannot control bacterial growth effectively, especially if the pipework allows water to stagnate or cool between uses.</li> <li>In a food preparation environment, this also raises additional hygiene concerns. Hot water is essential for effective hand washing and equipment cleaning. Using lukewarm water compromises these practices, increasing the risk of cross-contamination or poor cleaning standards.</li> </ul> | <p>The combi boiler pressure gauge is reading zero, indicating a loss of system pressure.</p> <p>Rectify as necessary to ensure it reliably heats water to at least 50 °C.</p> | |

| ISSUE 6: | COMBI BOILER (STORE ROOM 1) – NOT HEATING WATER | | |
|---|---|---|--|
| Source for recommendations: | | <p>Hot water should be distributed so it reaches a minimum temperature of 50 °C within one minute at outlets." [HSG 274 Part 2]</p> <p>Every sink must have an adequate supply of hot and cold water for washing food and be of drinking quality. (Food Standards Agency)</p> | |

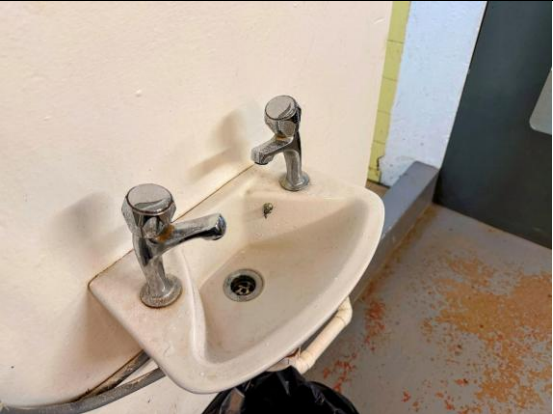
| ISSUE 7: CHANGING ROOM 2 – FAULTY BASIN COLD TAP | |
|---|---|
| | <div>ISSUE</div> <div> <p>The basin cold tap is not working.</p> <p>For a 360 photo view of the location, click <a href="#">HERE</a>.</p> <p><b>Why It Matters:</b></p> <ul style="list-style-type: none"> <li>A non-functioning cold tap means water is sitting unused in the pipework, creating a dead leg. Stagnant water at ambient temperatures (especially between 20–45 °C) provides ideal conditions for Legionella bacteria to grow.</li> <li>Without regular flow, biofilm can form inside the pipe, supporting bacterial colonisation. This can affect both the cold and, indirectly, the hot system due to cross-connection.</li> </ul> </div> |

| ISSUE 7: CHANGING ROOM 2 – FAULTY BASIN COLD TAP | |
|---|---|
| | <div>SOLUTION</div> <div> <p>The best option is to get the cold tap in Changing Room 2 working again. Flush thoroughly before use.</p> </div> |

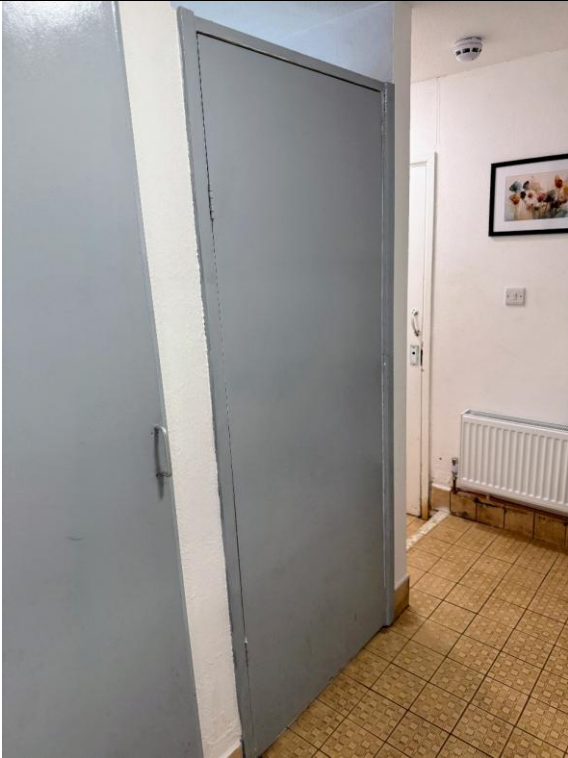
| ISSUE 8: | FEMALE TOILET – OUT OF ORDER TOILET CUBICLE | | |
|---|---|---|---|
| | <p>The far right toilet cubicle is out of order.</p> <p>For a 360 photo view of the location, click <a href="#">HERE</a>.</p> <p><b>Why It Matters:</b></p> <ul style="list-style-type: none"> <li>A non-functioning cold tap means water is sitting unused in the pipework, creating a dead leg. Stagnant water at ambient temperatures (especially between 20–45 °C) provides ideal conditions for Legionella bacteria to grow.</li> <li>Without regular flow, biofilm can form inside the pipe, supporting bacterial colonisation. This can affect both the cold and, indirectly, the hot system due to cross-connection.</li> </ul> | | <p>The lack of regular cistern flushing means water remains stagnant in this part of the system. Stagnant water can support the growth of Legionella and other bacteria, particularly if the cubicle is brought back into use without proper cleaning or flushing.</p> <p>It also creates a potential dead leg if left unused long-term. As such, the disused outlet should either be brought back into use or included in a weekly flushing regime.</p> |

| ISSUE 8: | FEMALE TOILET – OUT OF ORDER TOILET CUBICLE | | |
|---|---|---|---|
| Source for recommendations: | | <p><i>Stagnation can lead to conditions which encourage the growth of biofilm and legionella. To reduce the risk, outlets on hot and cold water systems should be used at least once a week to maintain a degree of water flow and minimise the chances of stagnation.” (HSG274 Part 2, para 2.50)</i></p> | |

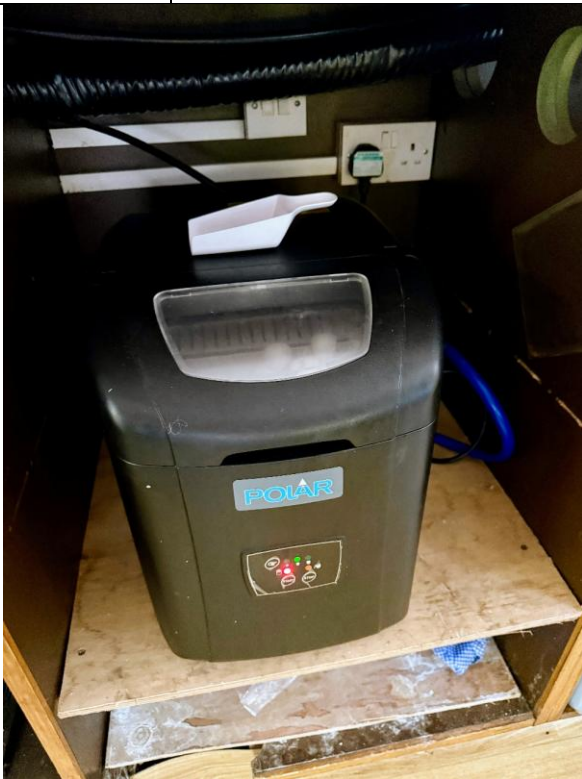
<table><tr><th>RISK LEVEL / TIMESCALE</th><th>MODERATE – PLANNED MAINTENANCE</th></tr><tr><td><p>The bar's ice machine chamber, whilst clean, should be included (if not already) in a 3-monthly cleaning regime.</p><p>Contaminated ice can result in Legionella infection, but other harmful pathogens are a notable risk.</p><p><b>Consequences:</b></p><p><b>Pseudomonas aeruginosa:</b> This bacterium is commonly found in water and can readily form biofilms. It can cause a range of infections, including skin infections, ear infections, urinary tract infections, and pneumonia, particularly in individuals with weakened immune systems.</p><p><b>Salmonella:</b> These bacteria are a common cause of foodborne illness, leading to symptoms like diarrhoea, fever, and abdominal cramps. Contaminated water used to make ice or poor hygiene during handling can introduce Salmonella into the ice.</p><p><b>What is Biofilm?</b> - In simple terms, biofilm is a sticky layer of microorganisms, like bacteria (including Legionella) and fungi, along with the slimy substances they produce. Think of it like plaque on your teeth, but inside water systems.</p></td><td><p>If not already in place, implement a three-month cleaning regimen and descale if scale is visible.</p><p>It is important to note that the Food Standards Agency emphasises that ice should be treated as a food product and handled with the same level of care and attention as other food items. This means that ice should be produced, stored, and served in a manner that minimises the risk of contamination and ensures its safety for consumption.</p><p>For a 360 photo view of the bar area – click <a href="#">HERE</a></p></td></tr></table>

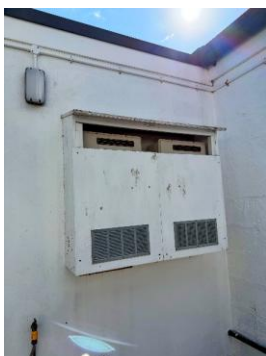
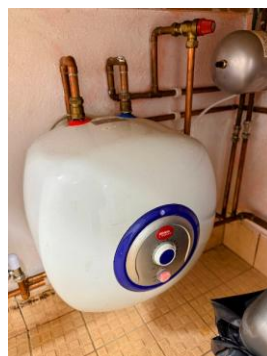
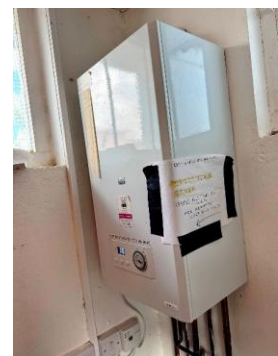
Types of hot water services installed include:

- Gas-Fired Water Heaters
- Point of Use Water Heaters
- Gas-Fired Combi Boiler
