**LEISURE AND AMENITIES COMMITTEE – 12 OCTOBER 2026****REPORT FOR DECISION****REQUEST FROM PENZANCE TENNIS CLUB TO REINSTATE ITS PREVIOUS  
ENTRANCE**

**LEISURE AND AMENITIES COMMITTEE – 12 OCTOBER 2026****REPORT FOR DECISION****TREE WORKS AT PRINCESS MAY RECREATION GROUND**

## Tree Management Survey

# WESTERN PROMENADE ALEXANDRA ROAD RAISED FOOTWAY

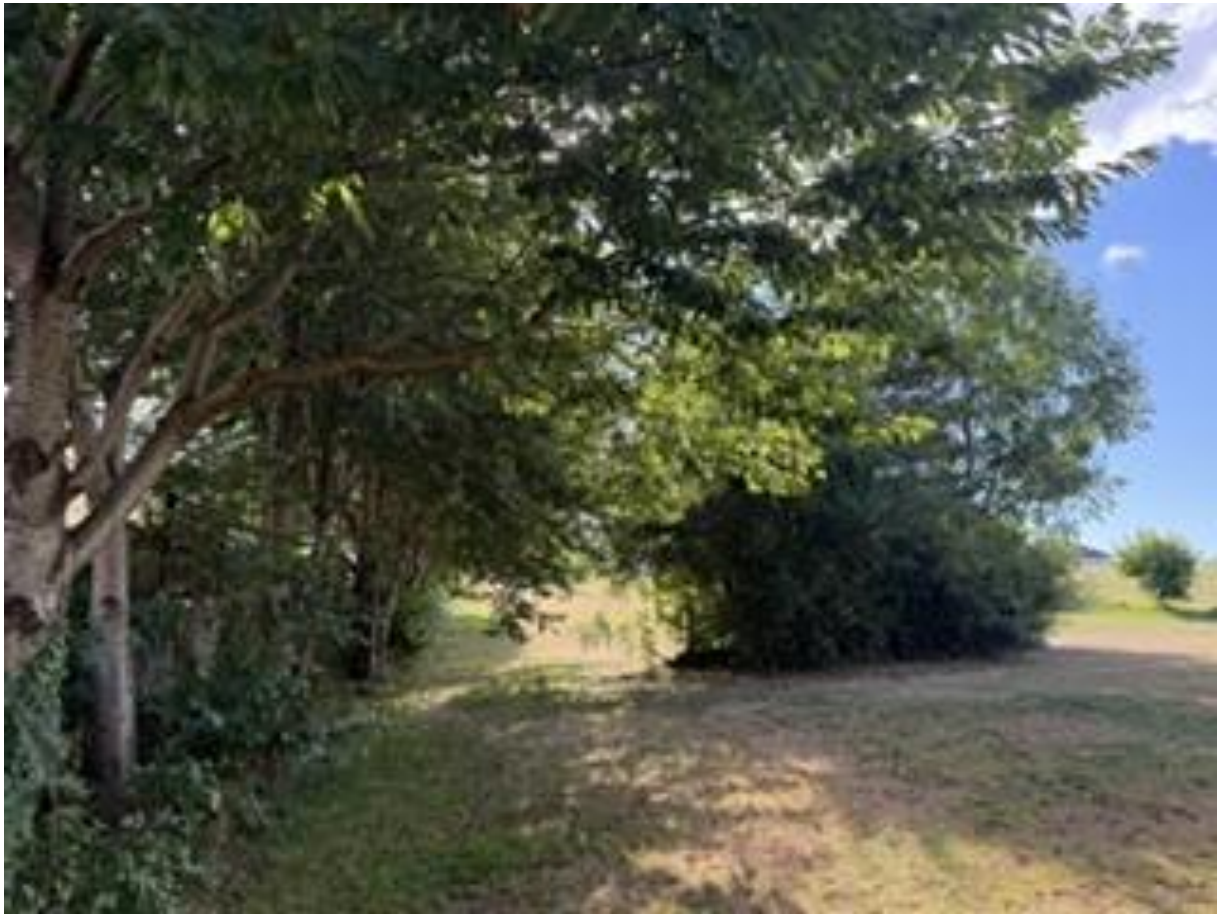
G1 Cherries.

- 1.5 G1 is a row of mature cherry trees which are planted just within the boundary and which have healthy canopies extending out over the garden areas of neighbouring properties.
- 1.6 T2 is a young Sycamore on the opposite side of the entrance path to G2 and the canopy extends over the path and garden.
- 1.7 T3 is a Sycamore with a canopy extending over the garden area of the adjacent house.

- 1.8 G1 – Cherries. Prune canopies on side of neighbours' properties to 1 metre to neighbours' side of wall. Raise canopy over park to 4 metres above ground level.
- 1.9 T2 – Sycamore. Prune canopy on neighbour's side in line with wall to suppress side branch growth.
- 1.10 T3 – Sycamore. Prune back to wall.

Reduce canopies to 1 metre beyond wall on neighbours' side. Raise canopies to 4 metres above ground level over park.

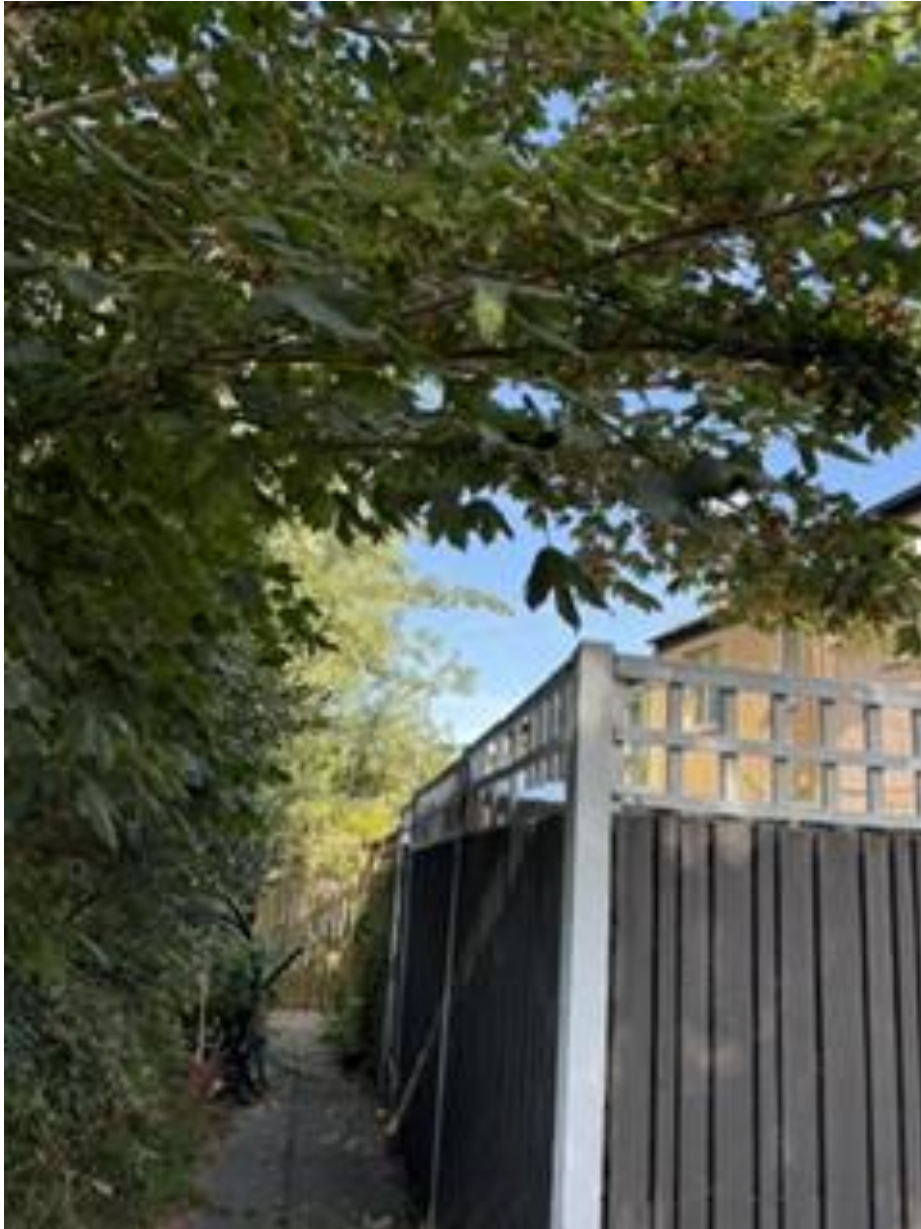
T2 – Sycamore in foreground prune branches back in line with wall.

T3 – Sycamore in background – also prune canopy back in line with wall.

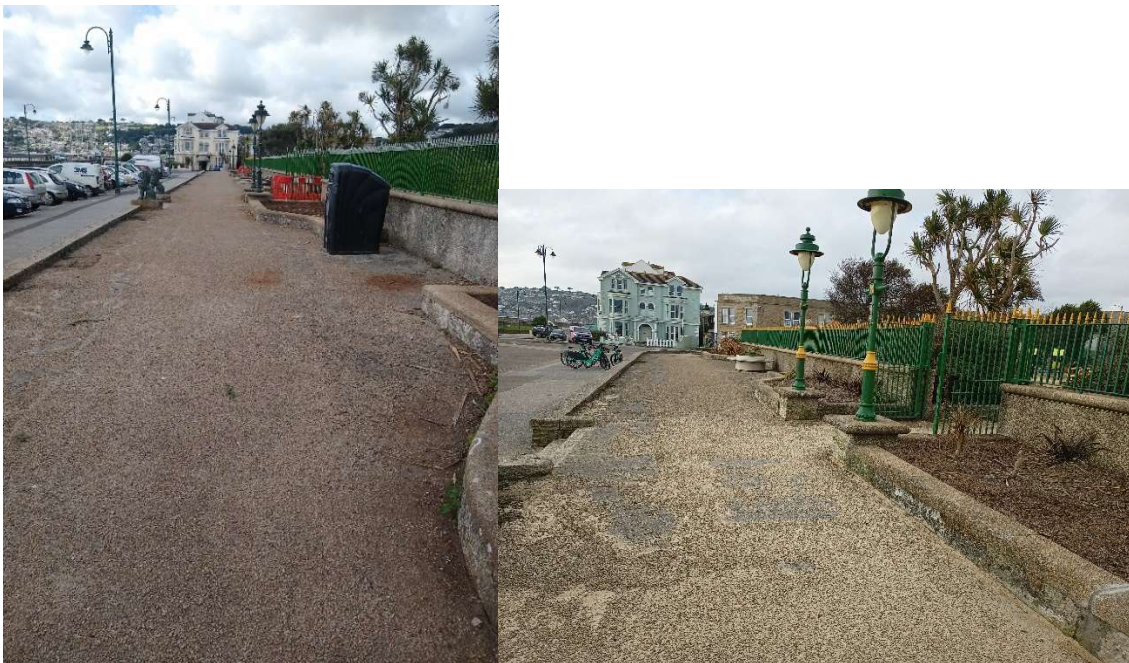
*Existing Terrace Surface (LH/2021 – RH/2024)*

The footway surface is a mix of tarmac and spread chippings. This has been patched and surfaced many times over the years. It currently has an uneven surface with exposed aggregate showing along with minor surface imperfections.

The finish has degraded further since the original report with loose aggregate leaving a patchy unattractive finish.

With the surfacing of the footway being weathered and worn we would recommend that the existing surface is replaced.

To replace the surface the existing 25-35mm top surface should be planed off leaving a level sub base ready to accept the top surface finish. This should be laid to appropriate falls allowing surface water to run towards drainage gullies or weep holes or the footway steps.

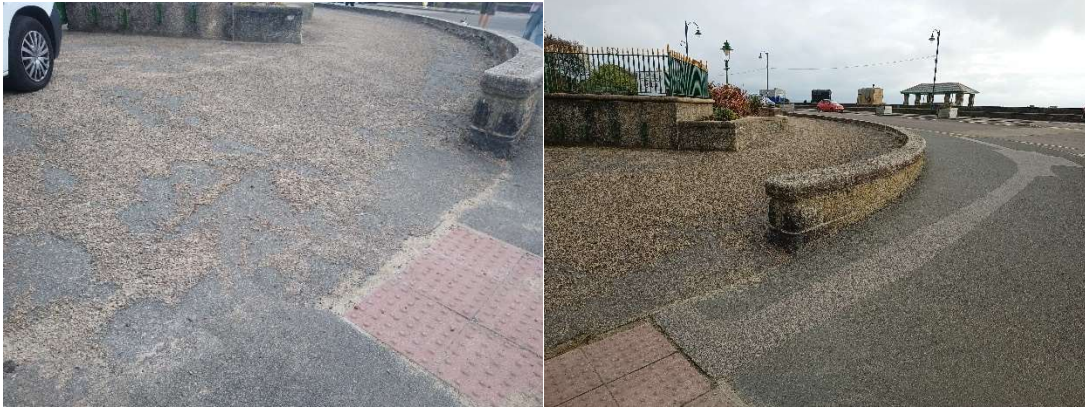
It is approximately 120 metres long by 5 metres wide (600m<sup>2</sup>) and is raised by 300mm above the adjacent pavement.

*Start of Terrace at Alexandra Road (LH/2021 – RH/2024)*

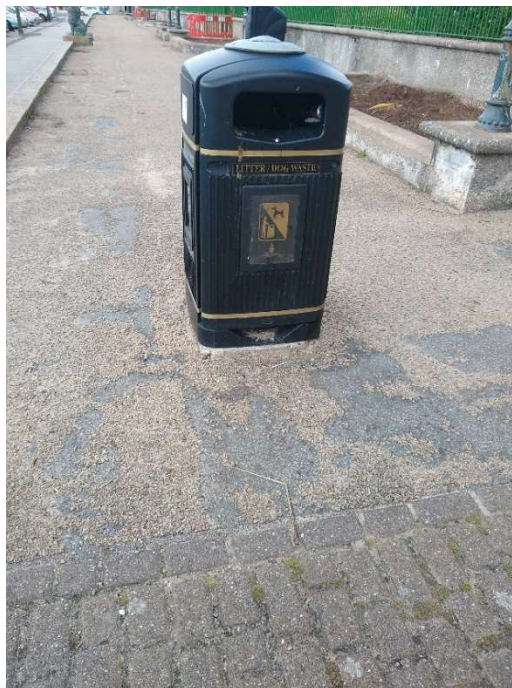
The eastern end of the footway the surface is finished with block pavements where it meets the Amusement Arcade.

*Eastern end of Terrace at Amusement Arcade*

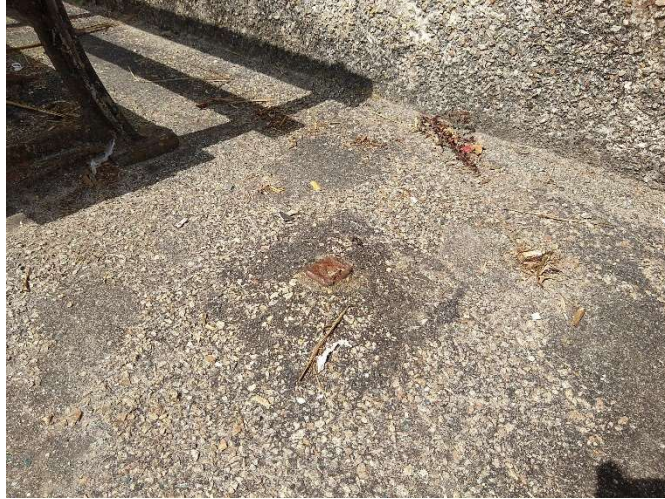
There are a couple of locations where previous seating bench feet/legs have been set into the surface finish. These over time have rusted away leaving slightly raised pieces of cast iron in the finish.

*Old Bench Footing*

These could constitute a trip or injury hazard and we would recommend they are cut back below the surface and removed.

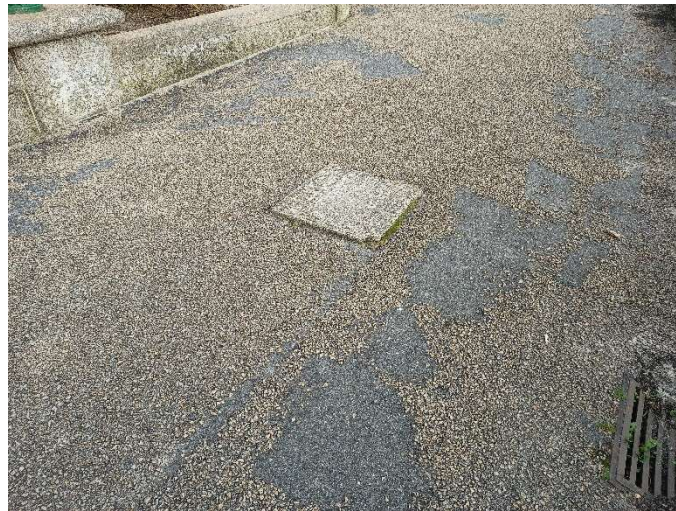
There is also a slightly raised access cover in the footway that is a trip hazard. The cover and frame are corroded and should be replaced.

*Raised access cover*

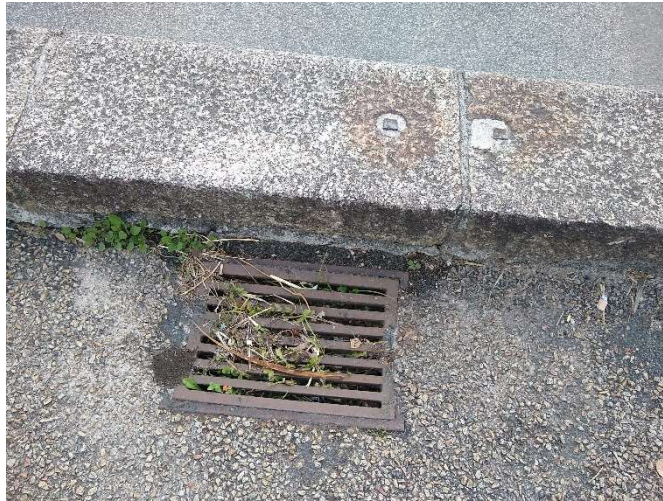
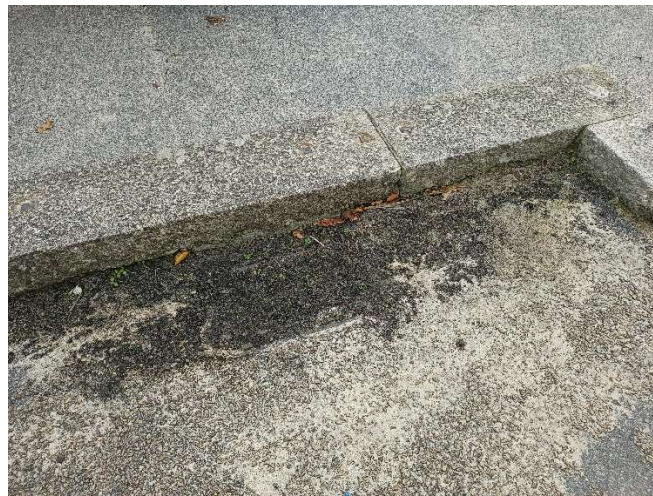
From looking at the surface it was apparent that the surface water drainage was collected via 1 cast iron drainage gully along the whole run of terrace. From careful inspection of the footway surface it appears that there may be additional drainage gully's that have been covered during the course of the surfacing many years ago. This was highlighted by an even depression(s) in the surface about the same shape and size of the existing visible drainage gully.

*Existing drainage Gully (2021)*

*Existing drainage Gully (2024)*

We are not confident of the existing drainage gullies capability to drain surface water due to visible debris and silt in the drainage gully chamber. The Gully still appears to be blocked. As such we would recommend that the existing drainage gully is opened and cleaned out with its operation checked to ensure it is free draining.

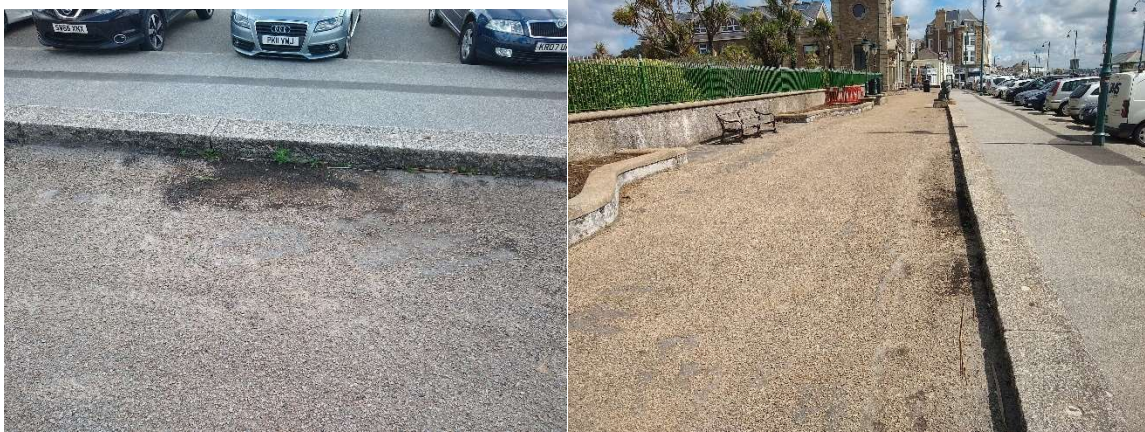
There are also some areas of silt/mud build up which would point to an uneven surface allowing water and debris to collect.

*Areas of Pooling Water leaving debris*

If additional drainage is deemed to be required then extra cast iron drainage gully's can be provided if there is a suitable surface water drain close by or alternatively, we could investigate the provision of weep pipes from the terrace to the public footpath below, however Cornwall Highways would need to be consulted.

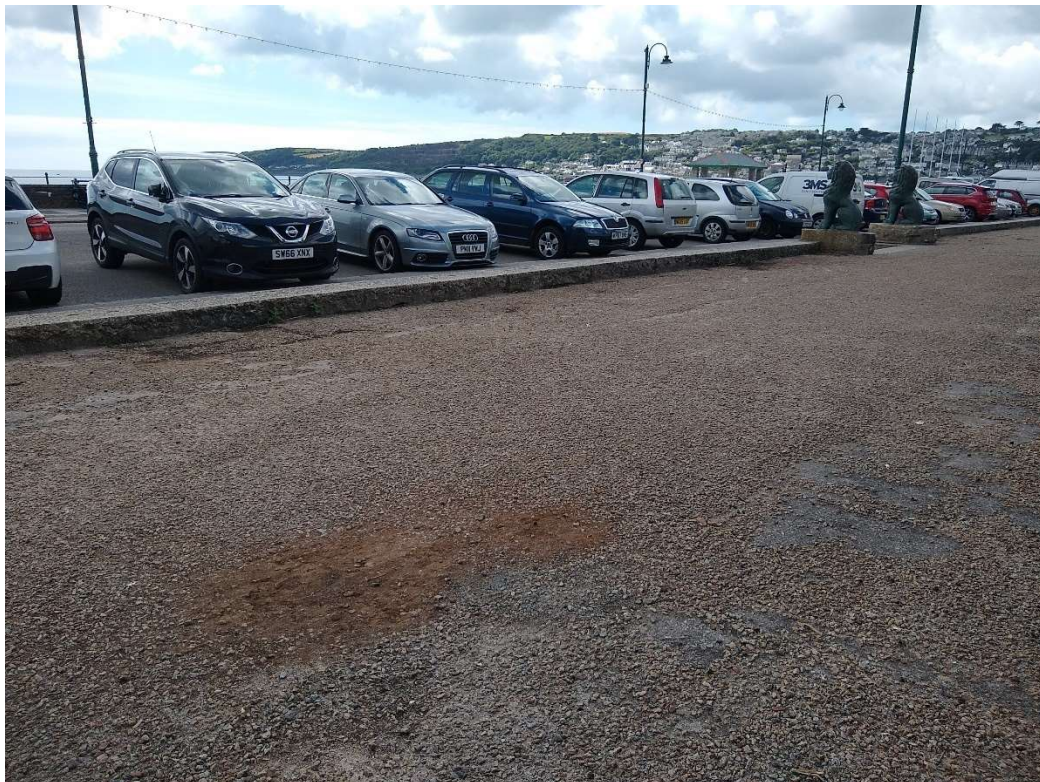
*Visible hollows in surface against Terrace Edge*

We would also recommend that the existing ground depressions along the outside edge of the terrace are investigated by opening out the surface finish to see if any underlying drainage gullies are present.

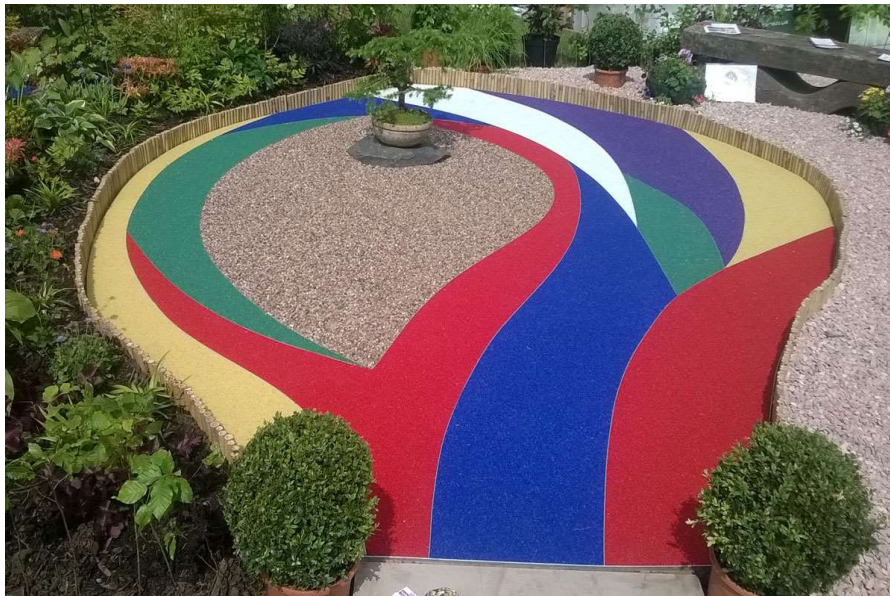
Resin bound finishes are also an option with coloured aggregate laid in a single colour finish or multiple colours laid in patterns. Patterns could reflect a theme (nautical, seaside) or colours used within the PZTC logo/colours.

*Typical Resin bound Patterned Finish*

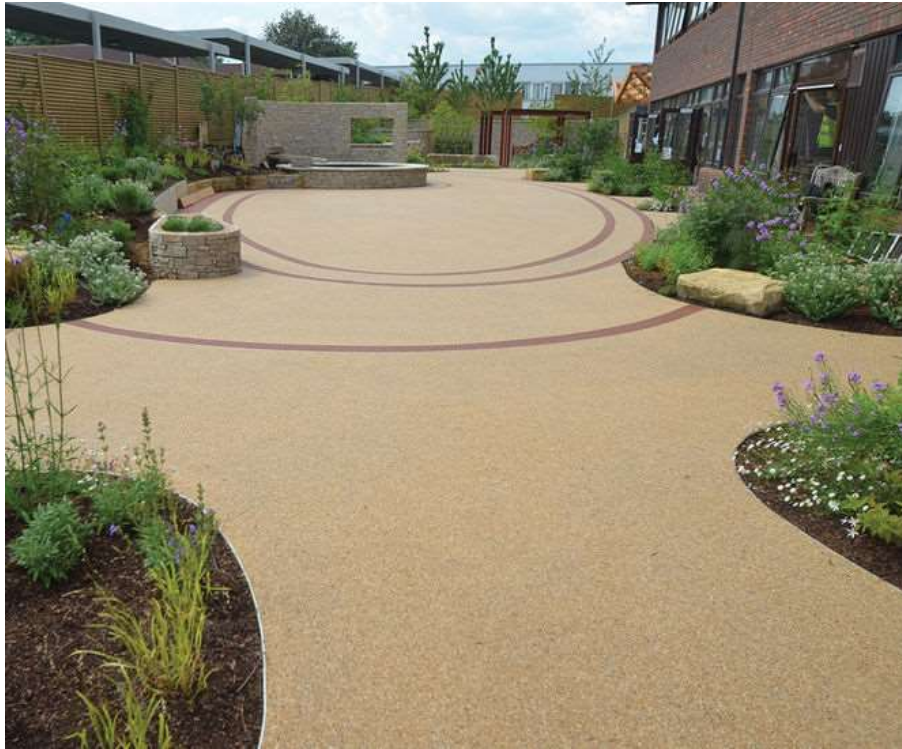
*Typical Resin bound Patterned Finish*

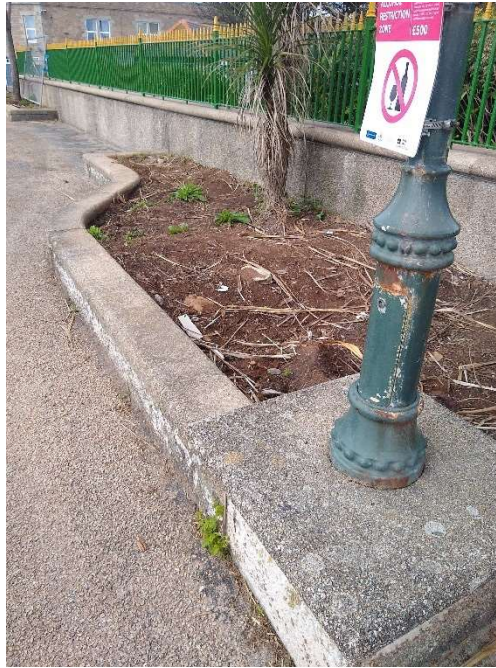
There are 4No raised planting beds along the terrace. These join with the Play Park perimeter wall. They are of concrete construction with a rendered finish and an exposed aggregate cast concrete capping surround.

*Typical Raised Planter*

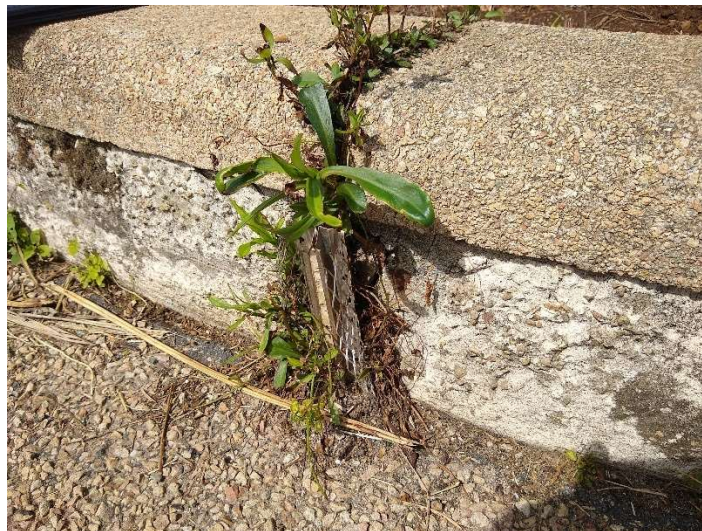
Generally, these beds are in reasonable condition, however some of the external render has come loose with exposed stainless steel beading showing.

*Failed Render and Exposed Beading / Weed Growth*

This appears to have been caused by a mix of general wear and tear along with weed penetration to the finish and joints allowing roots to part the render from the substrate. During the last 3 years the gardening team have been improving the beds and the general weeds have been removed.

We would recommend that the existing render finish to the planters is repaired or replaced with a new surface finish. When repairing a rendered surface it is difficult to match the surrounding finish and its best carried out on full panels rather than localised repairs.

Therefore, we would suggest that due to the size and area of the planters that the existing finish is removed and replaced with a new top surface.

The dwarf walls shall have a professional grade glyphosate weedkiller applied to be wall base and cracks to ensure there is no weed matter left which could cause issues later on.

A new render should be applied to the planting dwarf walls. This should have stainless steel render beads and expansion joint provision as per the existing construction. Render beads to be secured with stainless steel screws or nails to prevent premature failure.

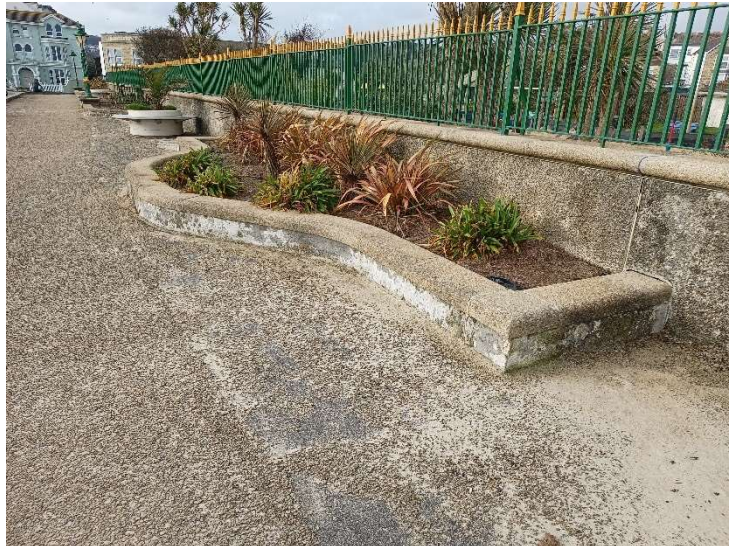
*General view of the planters (2024)*

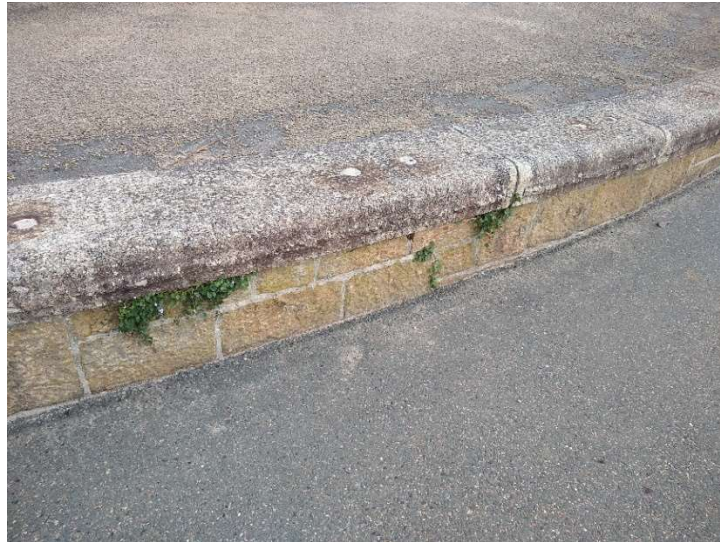
The terrace is edged with granite capping stones laid along the footway. These originally had cast iron decorative railings inset. It is assumed that these railings were removed as part of WW2's war effort scheme to supply industry with metals.

*Typical Terrace Edge Upstand*

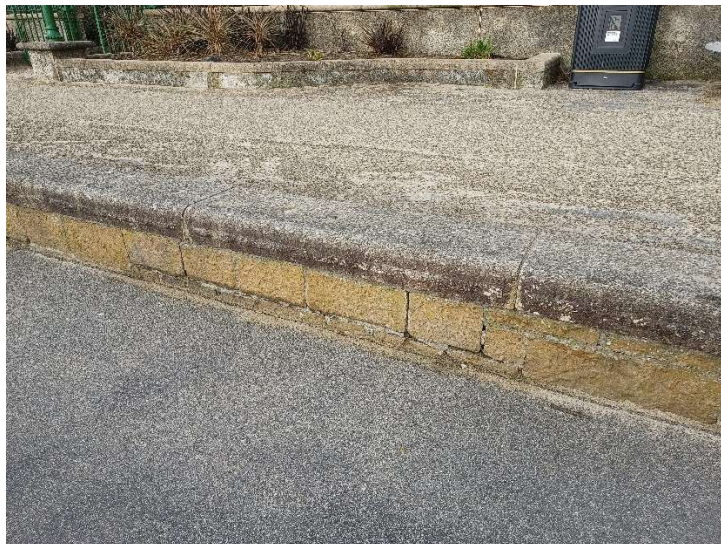
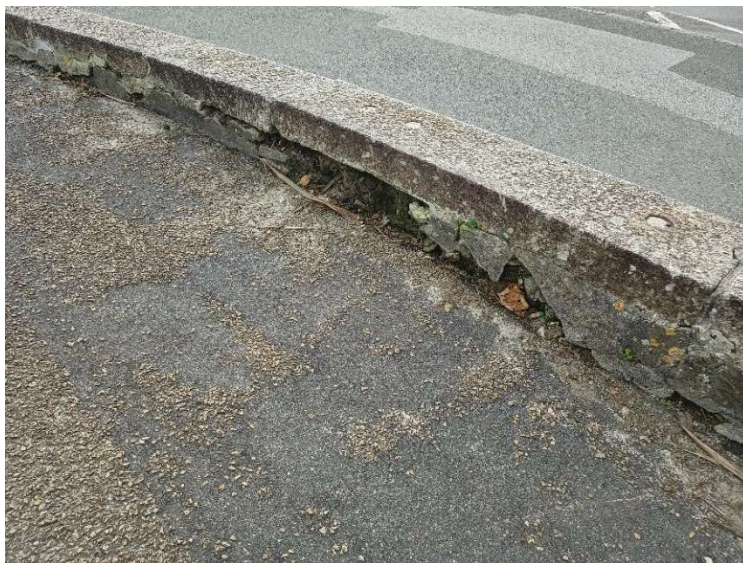
*Terrace Edge with Failing Mortar (2024)*

*Mortar pointing/render displacement (2024)*

These stones are set on a mortar bedding with mortar pointing. Over the years some of the bedding and pointing have become loose with a few stones now slightly displaced. This is noticeable in the areas of the steps down to the public footpath where the ground appears to have moved slightly.

Another area that has since become evident is the inside face of the wall/upstand where the render/pointing has failed and has broken away leaving exposed bare rubble. This will further deteriorate over time requiring more substantial repairs to be made.

It is recommended that the terrace edges and wall below are high pressure jet washed to remove any loose material such as pointing, dirt, weeds etc.

Any remaining loose mortar or pointing to the capping stones shall be removed leaving a clear stable substrate. The mortar bedding shall be reinstated along with new pointing to secure.

The rendered internal face of the upstand wall shall have the damaged render removed and the substrate checked for integrity. Where in poor condition the substrate shall be raked out and replaced with masonry/mortar mix. The internal face of the upstand shall be rendered with a suitable mortar mix.

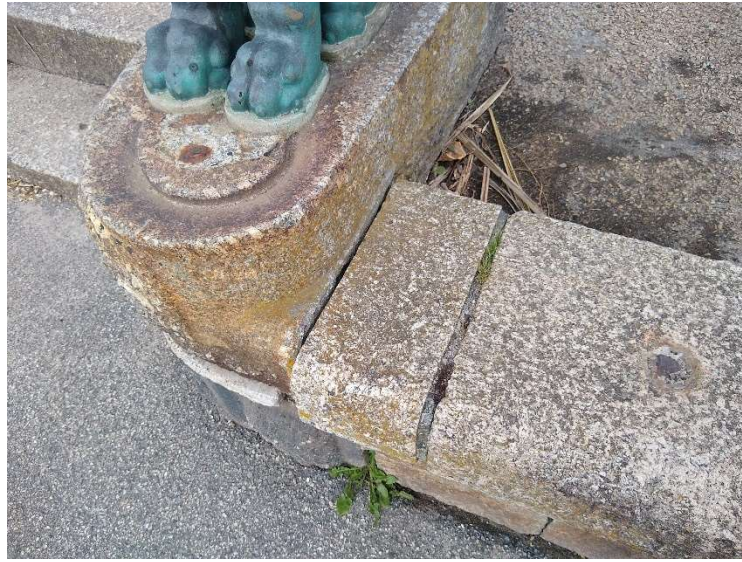
*Loose Capping Stone*

This historical movement has led to the capping stones becoming loose.

This movement was more pronounced on the step edges where the cast bronze lions are mounted.

It is possible that the greater weight has caused additional movement.

The feature bronze lions' step capping's should ideally be temporarily removed and the foundations inspected to ensure they are secure. Loose bedding material shall be removed to leave a stable secure base.

If the base foundation is found to be insufficient, then concrete pad foundations are recommended. This would sit below the capping behind the walling edges and would be 150-200mm thick. The pad would extend out past the capping stone approximately 300mm inside the wall to provide a good secure mass to accept the stone.

When the foundations are cast the capping stones with lions can be replaced on a level bed of mortar or grout to level and secure. It may be prudent to secure the capping stones with two additional stainless steel pins set into the foundations with an epoxy grout.

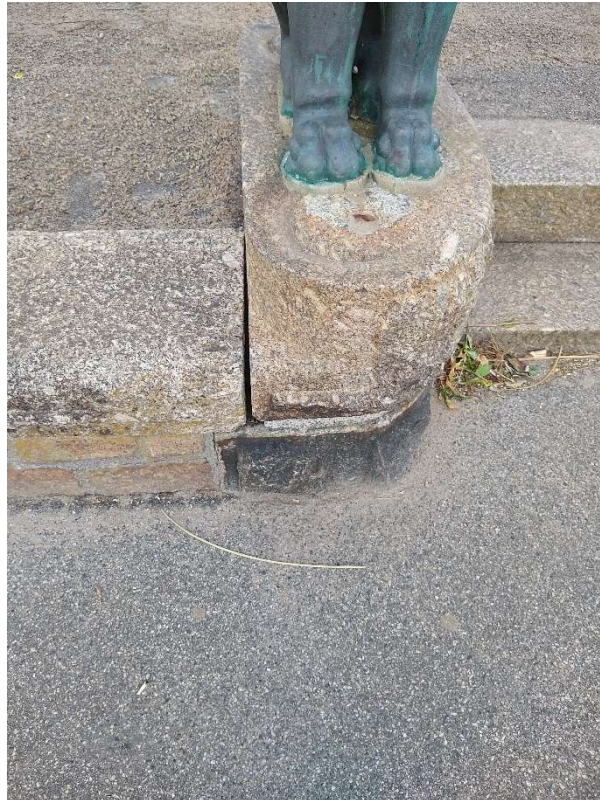
*Displaced Capping Stone and Bedding*

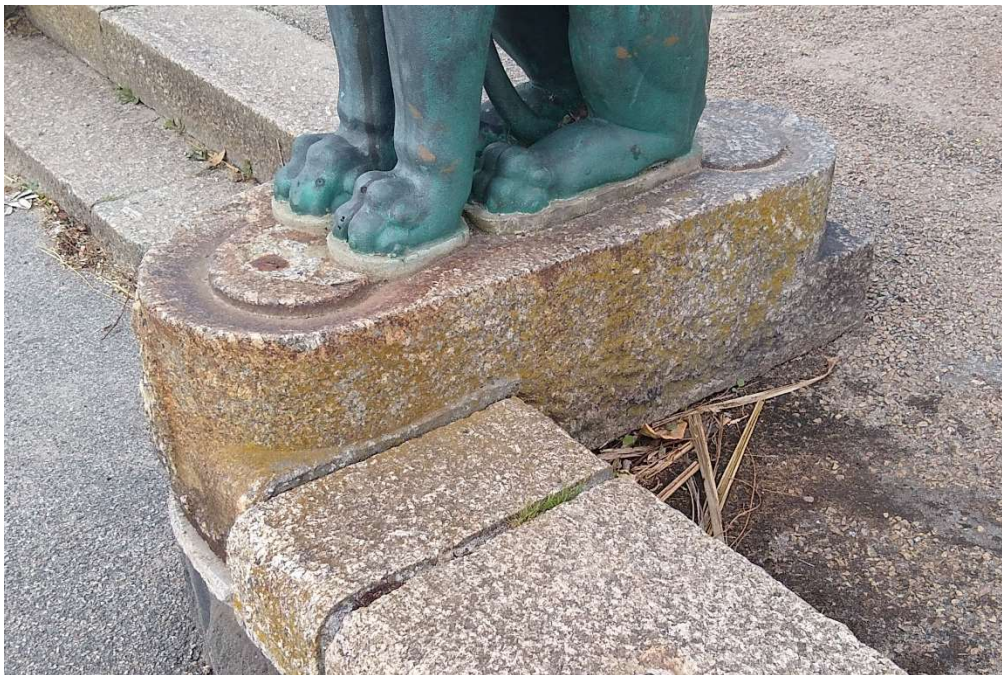
The capping stones sit on the wall below which is made up of cut granite stones set with a mortar fill and pointing. Again like the capping stones some of the mortar has become loose and requires repair.

*Loose Bedding, Pointing with Debris under stone*

The pointing of the lower wall section shall be inspected and loose sections of pointing shall be removed and repaired.

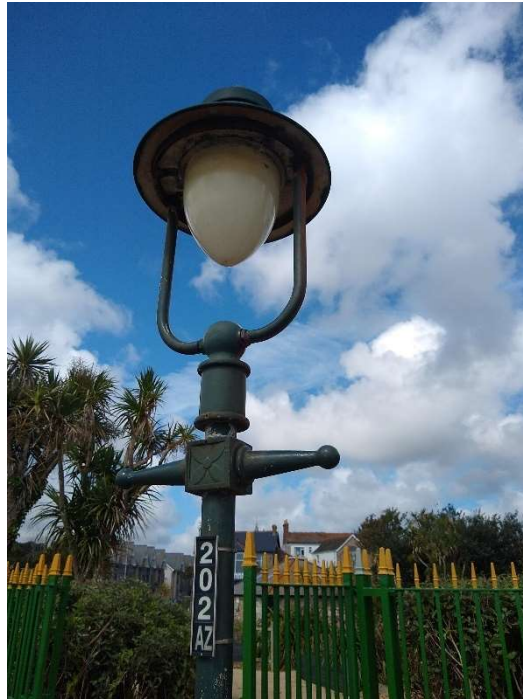
The existing 6No cast iron posts and post top lanterns have been repainted as part of the Play Park works, however the lanterns and post internals have not been refurbished.

*Typical Existing Column*

Internally the posts are fitted with a standard highways arrangement of fused incomer, connection block and distribution cabling rising to the lantern. These fittings are showing signs of corrosion with rusted screws fixings and cable connections.

We would recommend that Cornwall Highways are asked to inspect the fittings to see if the electrical supplies to each column are live.

The internal cut outs and switchgear should be replaced.

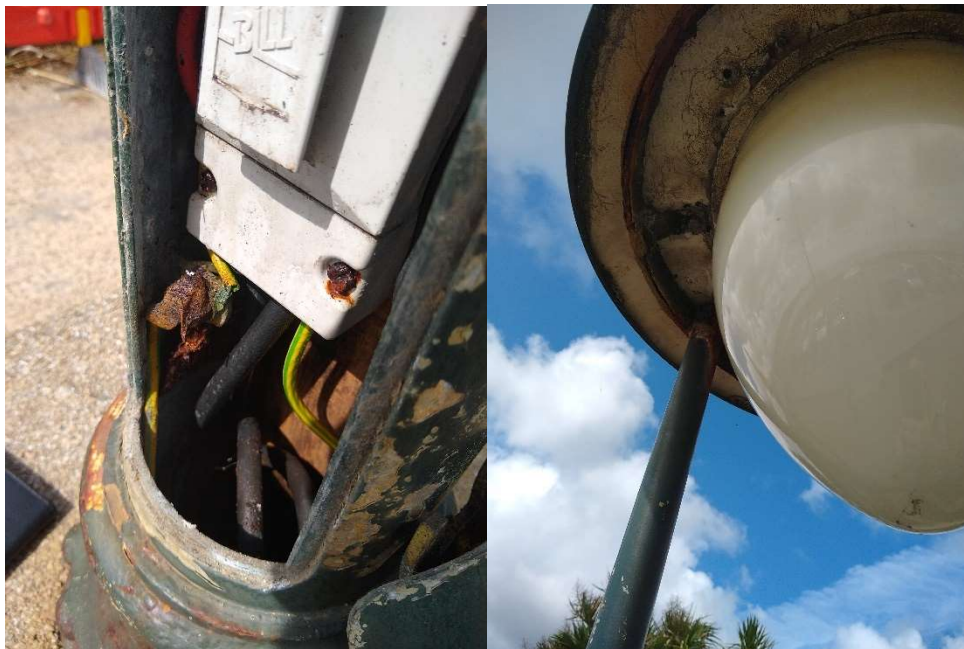
*Existing Lighting Columns*

The lanterns are non-original and have been replaced possibly in the past 20 years or so. Again, the lanterns are showing signs of corrosion with holed and pitted lantern shade, discoloured lantern diffusers and badly corroded support metalwork. It is not known if these fittings are operational.

The post top fittings should be replaced with new replacement items. In researching we believe that the fittings are manufactured by 11:11 Lighting Solutions Ltd in Portsmouth.

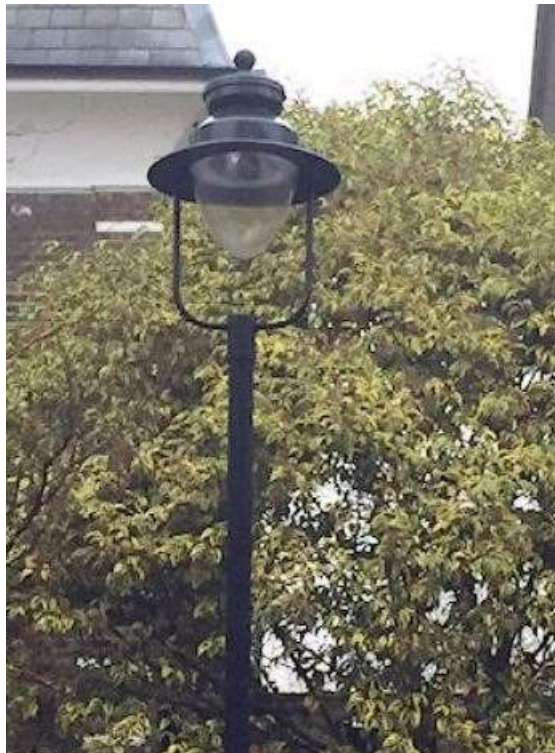
*Lighting Solutions Preston Light Fitting*

The lamp fittings are thought to be their Preston Cradle model. With advances in lamp technology LED lamps should be installed to offer lower operating costs along with longer lamp life.

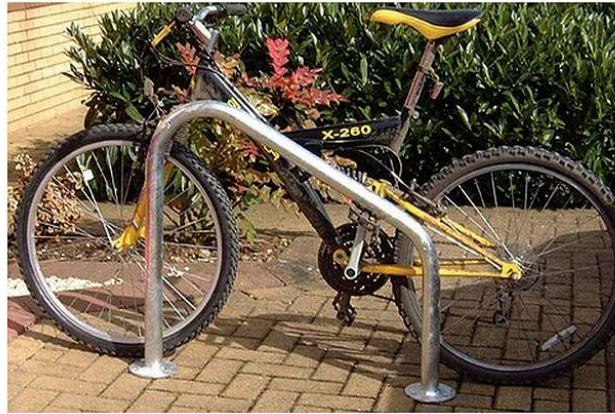
A further enhancement could be to omit some of the benches and utilise the space for cycle storage this could take the form of a wall mounted bike stand or ground mounted stainless steel hoops.

*Stainless Ground Mounted Cycle Hoop*

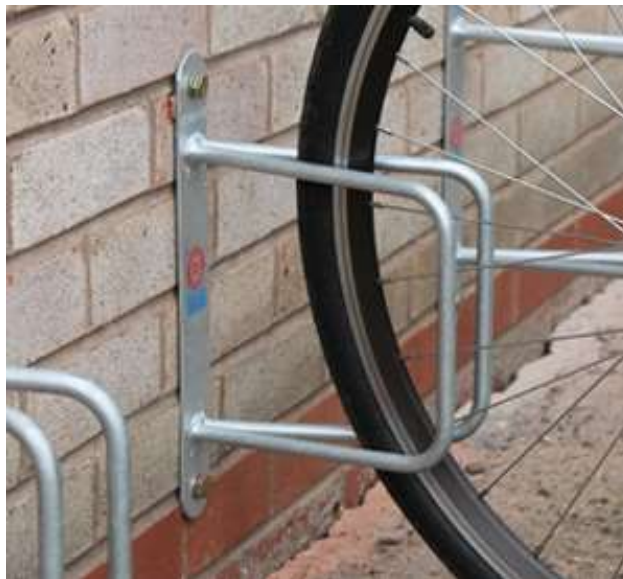
*Wall Mounted Cycle Stand*
