**LEISURE & AMENITIES COMMITTEE – 23 JUNE 2025****REPORT FOR INFORMATION****EXTERNAL PLAY AREA INSPECTION REPORTS**

# Safety Inspection Report

## Alexandra Play Park & Tennis Courts

Item 8(b) - Appendix 3  
**Alexandra Park  
 and Tennis Courts  
 Tree Safety  
 Survey 2025**

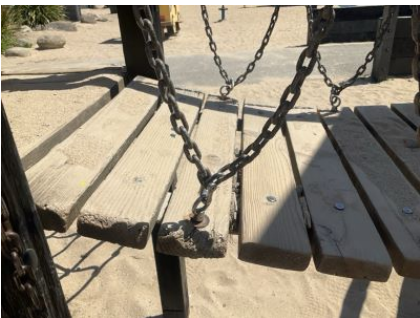
# Maintenance Finding

Timber is decayed.

Risk score:  
 4

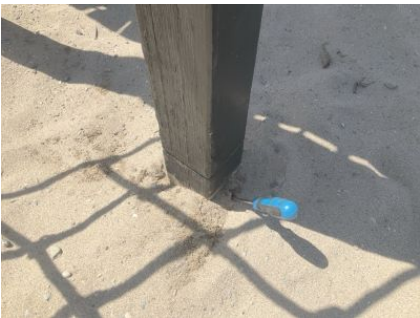
# Maintenance Finding

Item has corrosion.

Risk score:  
 4

Treat and repair.

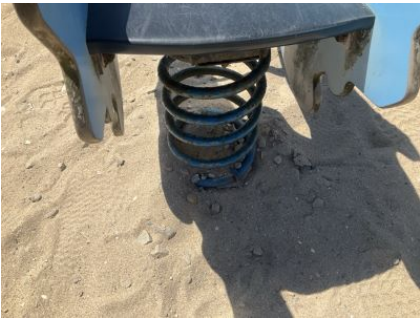
Fixtures loose or missing.

Spring loose in base plate.

4

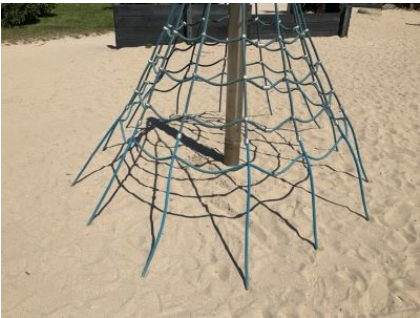
Additional comments are noted below.

4

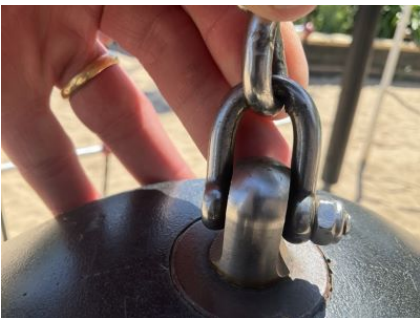
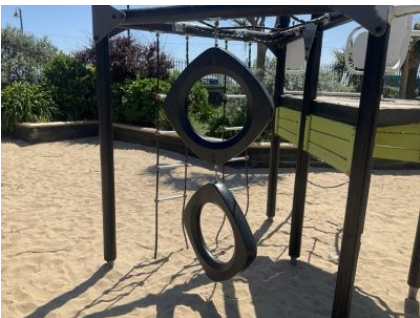
8

Replace the worn parts.

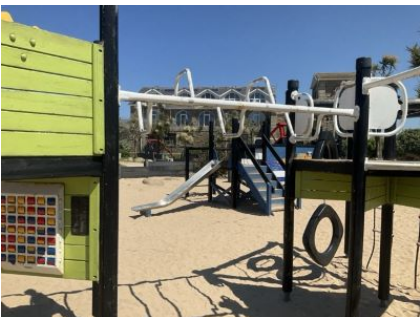
# Maintenance Finding

Overhead ladders and rings provide significant play value and benefits to children, and with it the risk of falling. Ensuring the surface remains in good condition will help to keep the correct balance between benefits and risk.

7

The protective surface under all bars and rings must be kept in good condition.

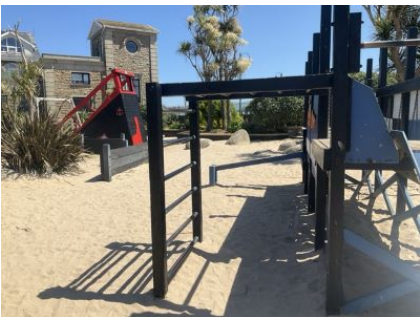
# Maintenance Finding

Overhead ladders and rings provide significant play value and benefits to children, and with it the risk of falling. Ensuring the surface remains in good condition will help to keep the correct balance between benefits and risk.

7

The protective surface under all bars and rings must be kept in good condition.

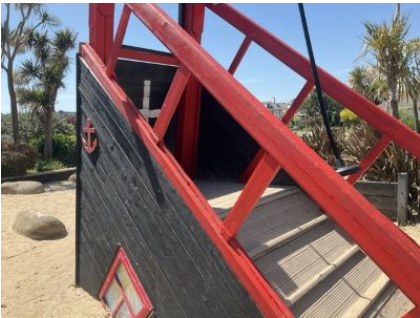
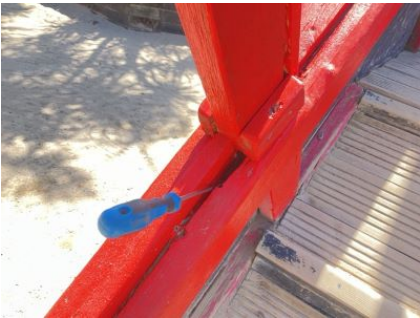
Fixtures loose or missing.

Red barrier loose, possible decay. Repair.

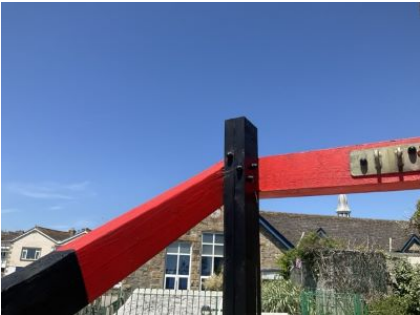
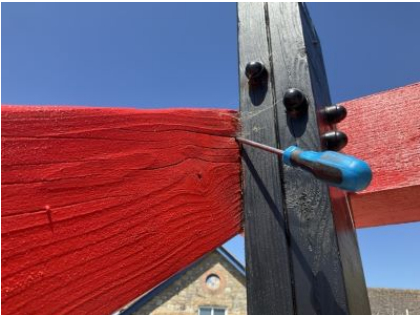
Timber is decayed.

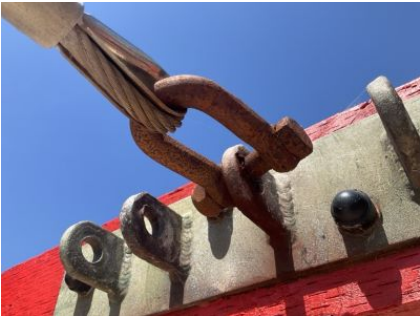
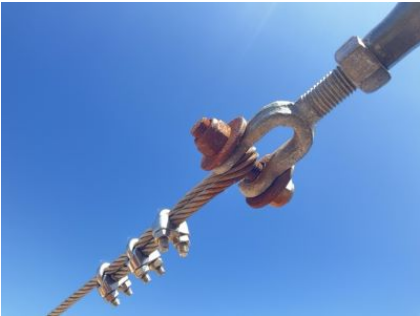
Connector is notched at end section.  
Some surface rust on looped part of cable at start section.

Replace.

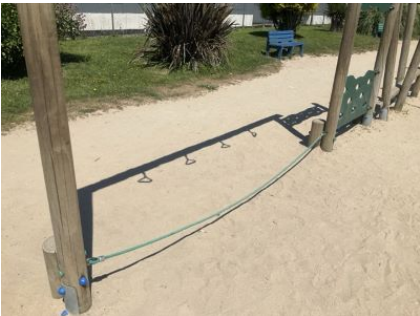
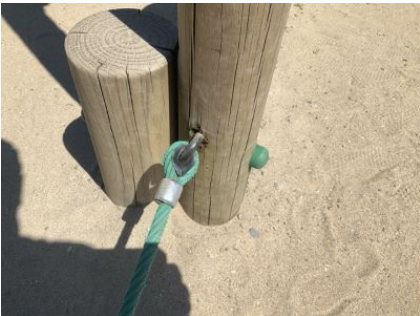
Bolt(s) loose.

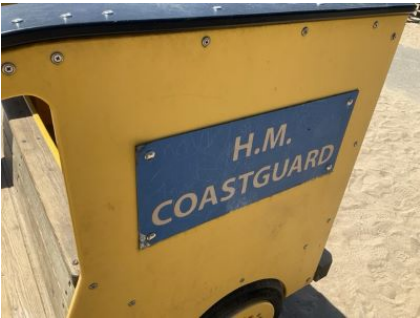
Damaged sign.

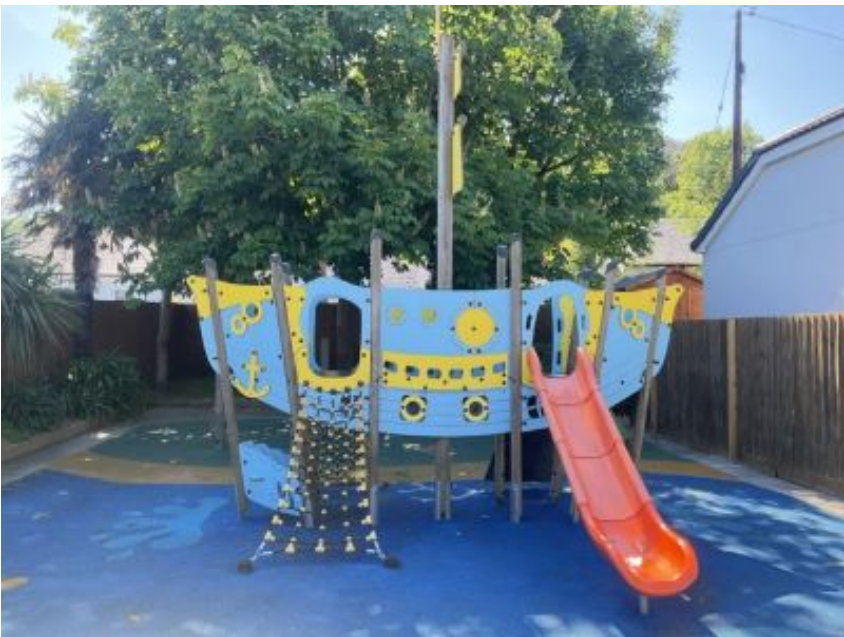
# Multiplay - Ship

Item is cracked.

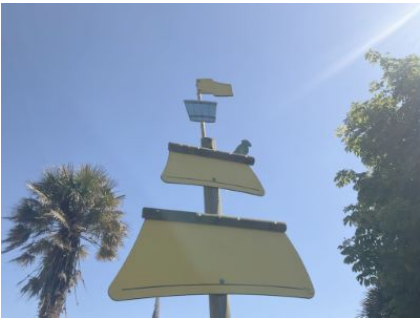
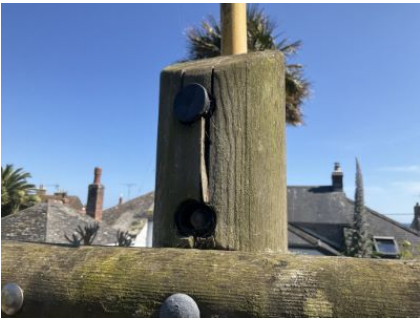
Cap missing.

Replace.

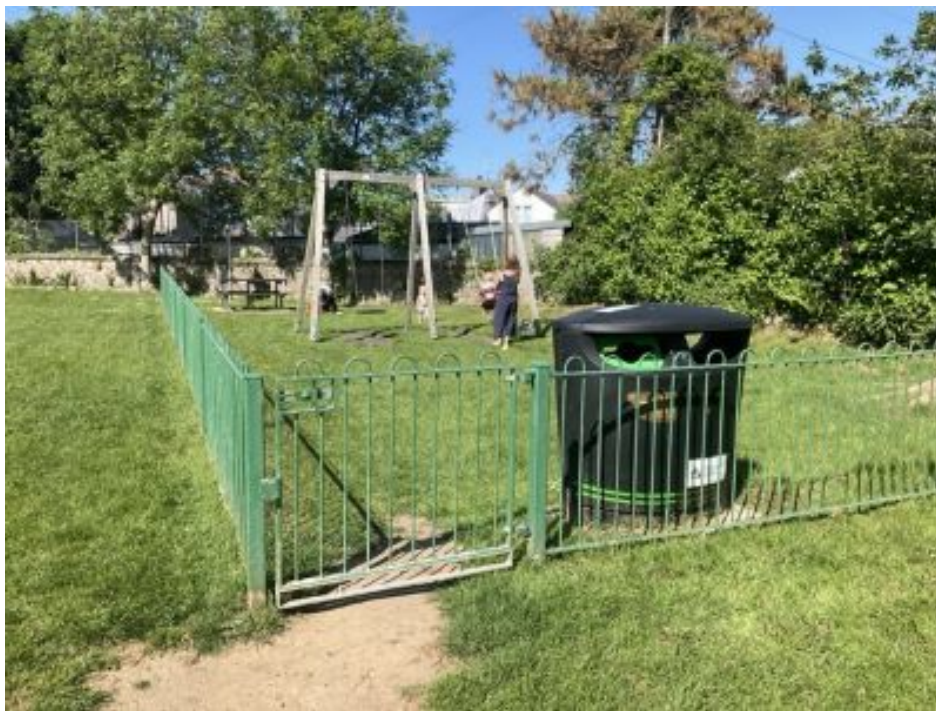
## Gates

**Description**  
 Item is rusting in places.

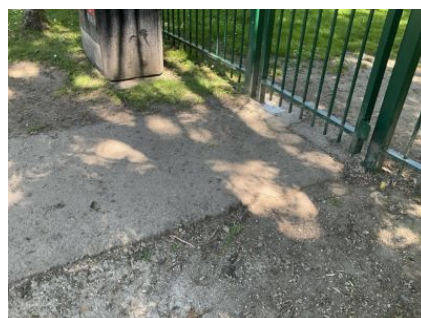
Surface: Grass

Surface is uneven.

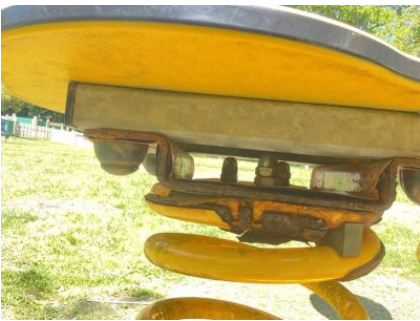
Item has corrosion.

Treat and repair.

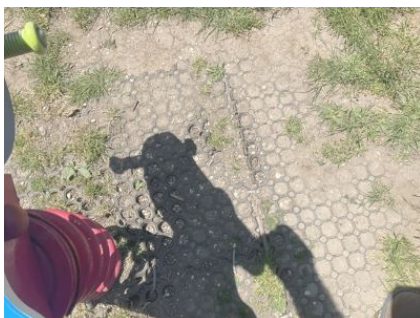
Surface is wearing.

Monitor for significant deterioration and rectify when necessary.

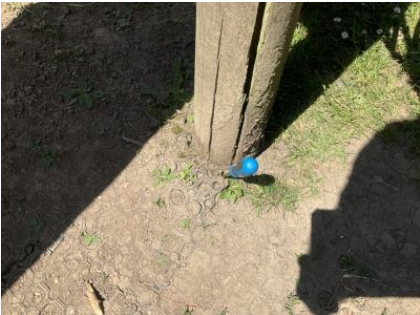
Timber is decayed.

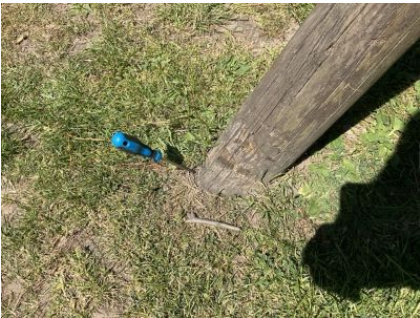
Timber is decayed.

Strimmer damage and minor decay to supports at surface level.

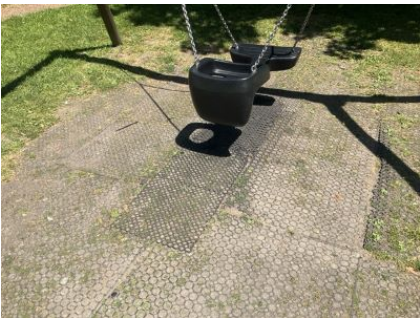
Surface is wearing.

Monitor for significant deterioration and rectify when necessary.

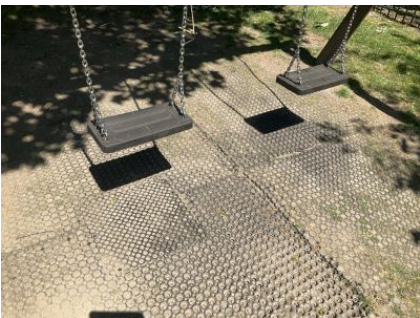
Surface is wearing.

Monitor for significant deterioration and rectify when necessary.

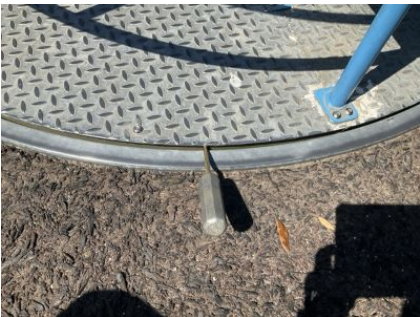
The item has the following maintenance findings:  
1. Surface is wearing.

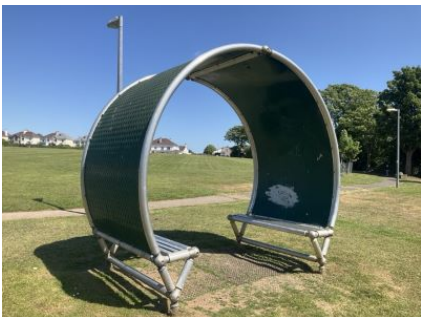
| Description | Tasks | Risk score |
|---|---|---|
| Item is rocking. | Repair. | 8 |

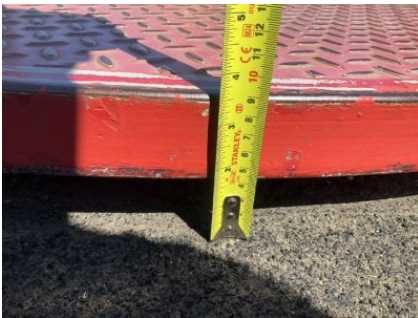
The bearings are worn.

Replace the worn bearings.

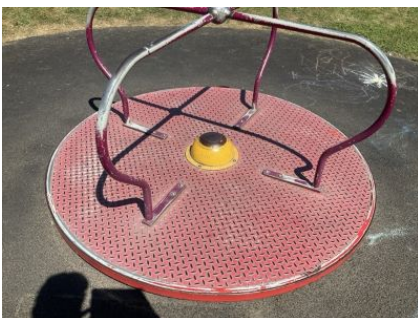
Surface is wearing.

Monitor for significant deterioration and rectify when necessary.

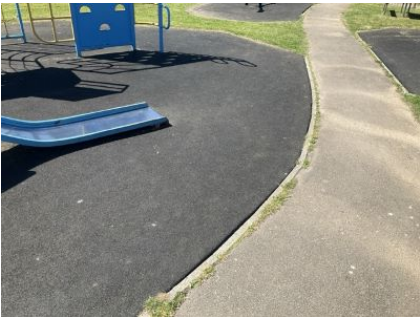
Shrinkage / separation of the surface. This may give a trip hazard.

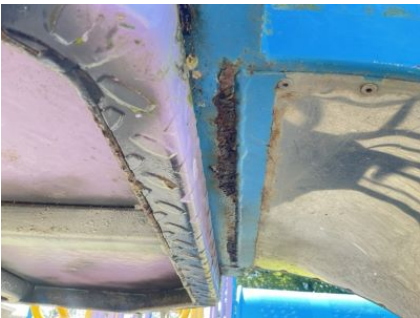
Item has corrosion.

Treat and repair.

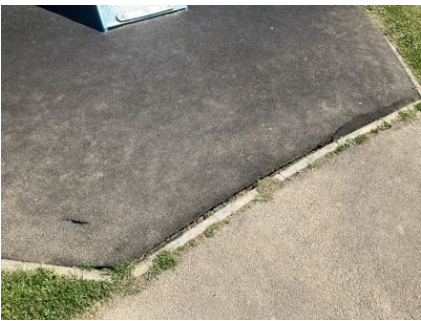
Shrinkage / separation of the surface. This may give a trip hazard.

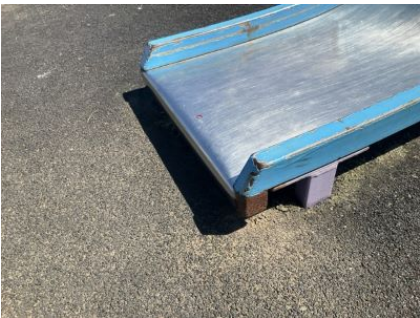
Item has corrosion.

Treat and repair.

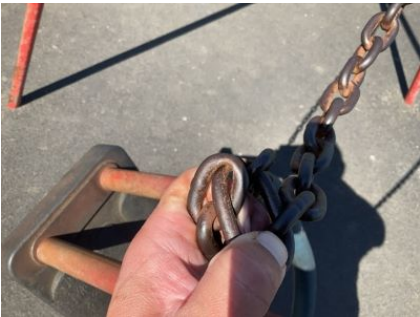
Some chain wear.

Monitor for further deterioration and replace before 40% wear.

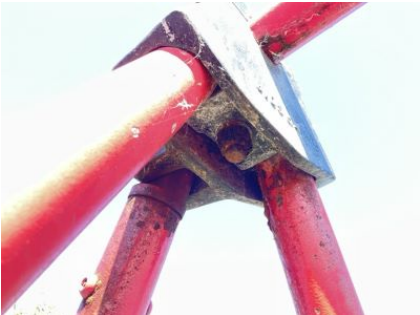
Item has corrosion.

Treat and repair.

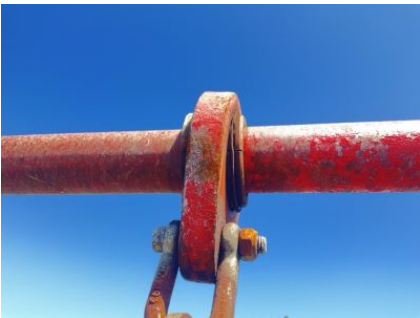
The anti-wrap shells are worn.

Replace.

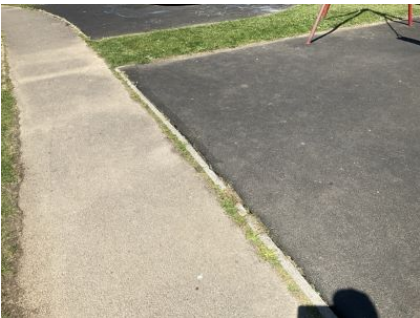
Shrinkage / separation of the surface. This may give a trip hazard.

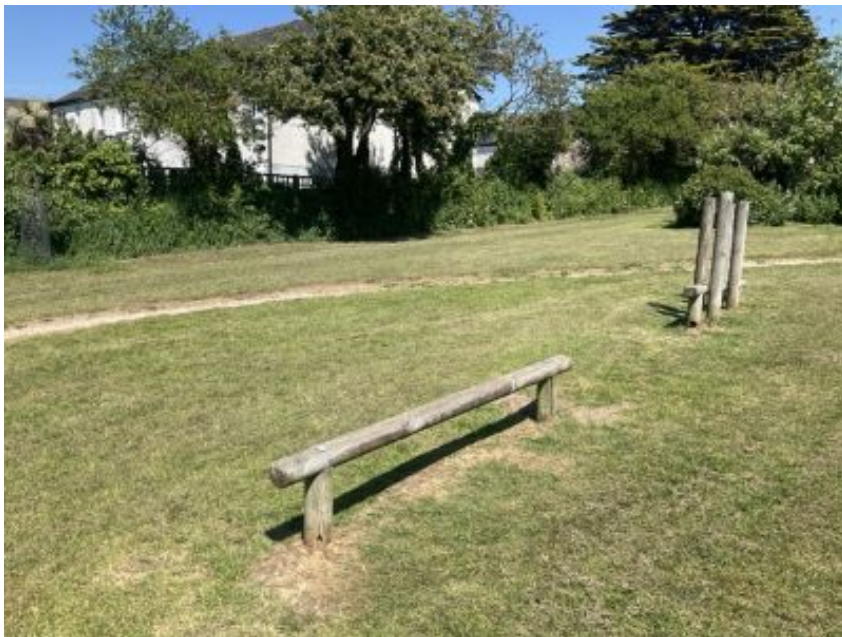
## Agility - Balance Beams (Beyond Skate)

Timber is decayed.

Strimmer damage and decay. Monitor stability and remove as worsens.

Prevent further damage., Check on a routine basis.

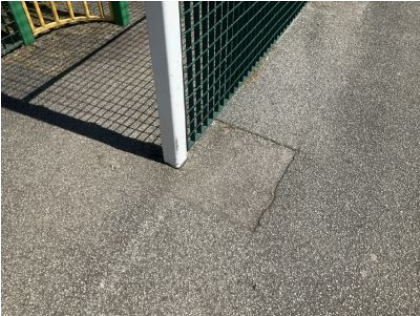
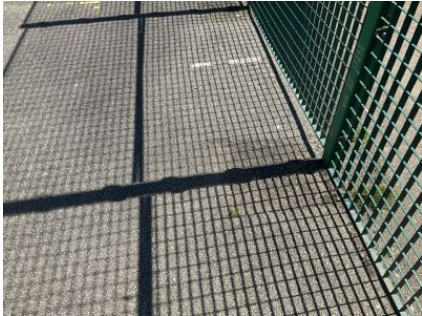
Loose in ground.

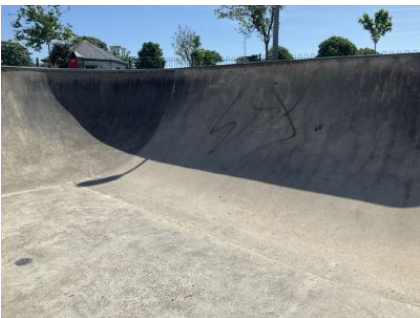
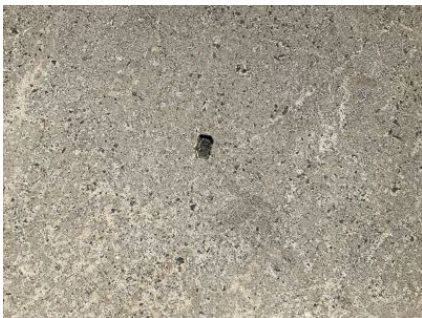
Surface is wearing.

Monitor for significant deterioration and rectify when necessary.

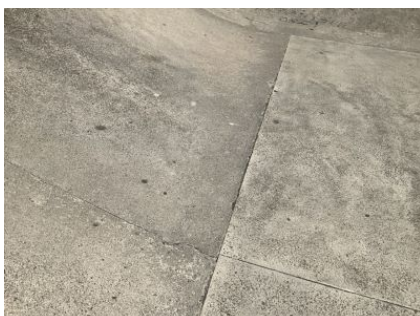
Surface is wearing.

Monitor for significant deterioration and rectify when necessary.

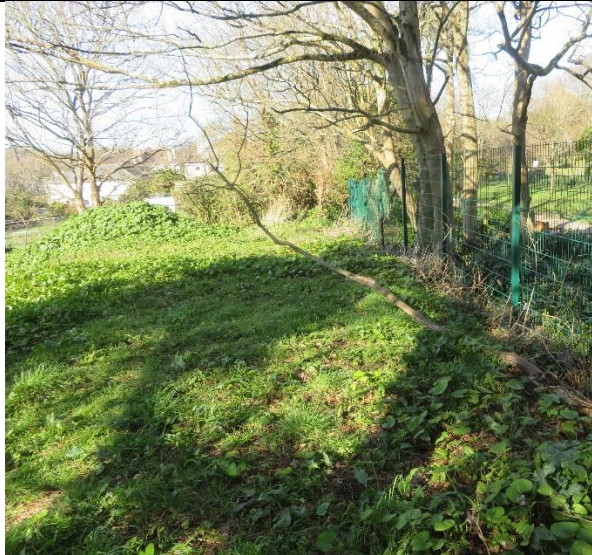
T5, collapsed Sycamore in foreground.  
Remove.

T4 Dead Elm in group visible in far corner.  
Remove.

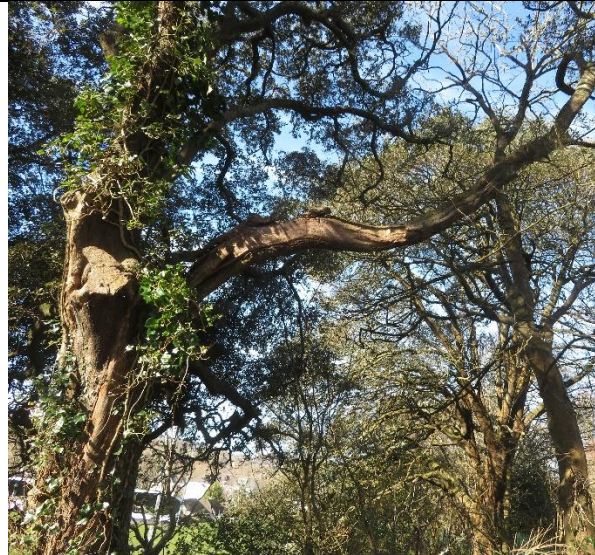
T106

Evergreen Oak with compromised  
lower branch. Remove branch.

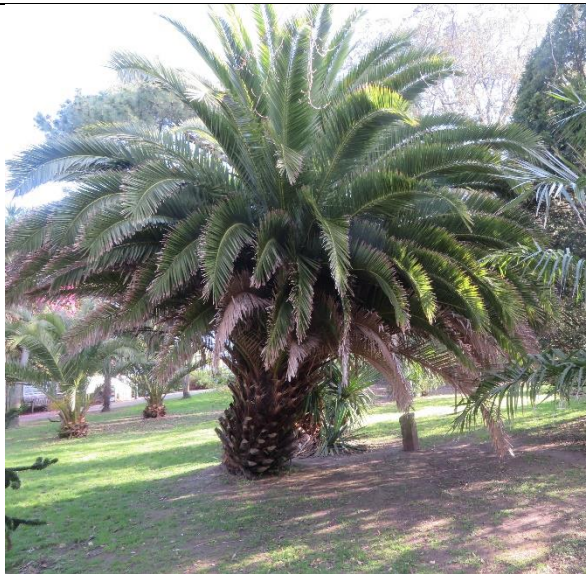
| Tree Tag | Species | Age | Size | Comments | QTRA Fields (Target, Size, PoF) | Recommendations and Time Priority | QTRA Outcome |
|---|---|---|---|---|---|---|---|
| 74 | Holly | D | S | Dead | 2/4/2 | Remove within 12 months | Dead tree failing<br>2/4/2 = < 1/50k |

1871 Dead myrtle stem to left of centre in top right photo. Remove.

74 Dead Holly in photo above. Remove.

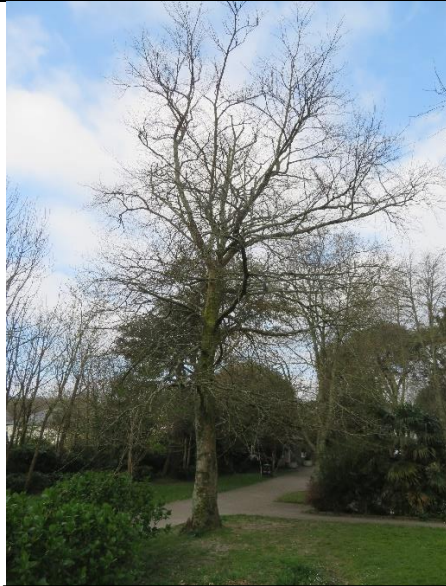
| Tree Tag | Species | Age | Size | Comments | QTRA Fields (Target, Size, PoF) | Recommendations and Time Priority | QTRA Outcome |
|---|---|---|---|---|---|---|---|
| G424 | Ilex Oak x 2 | M | L | Decay in structural stems and large branches. Good occlusion rib reaction. | 2/1/5 | Monitor annually | Stem failure and harm to people and property<br>2/1/5 = 1/400k |
| 1904 | Copper Beech | EM | M | Squirrel damage branch loss in high crown. | 3/3/3 | Monitor annually | Branch failure harm to people<br>3/3/3 = 1/500k |

424 Ilex Oaks. Monitor.

1904 Copper Beech. Monitor.

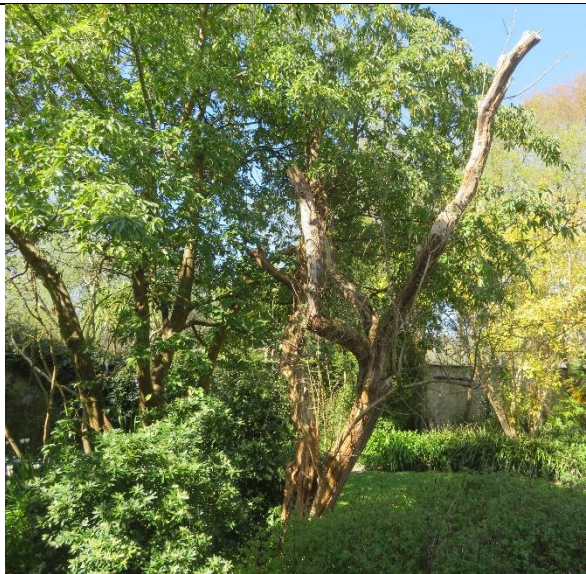
79 above and left Goat Willow. Monitor.

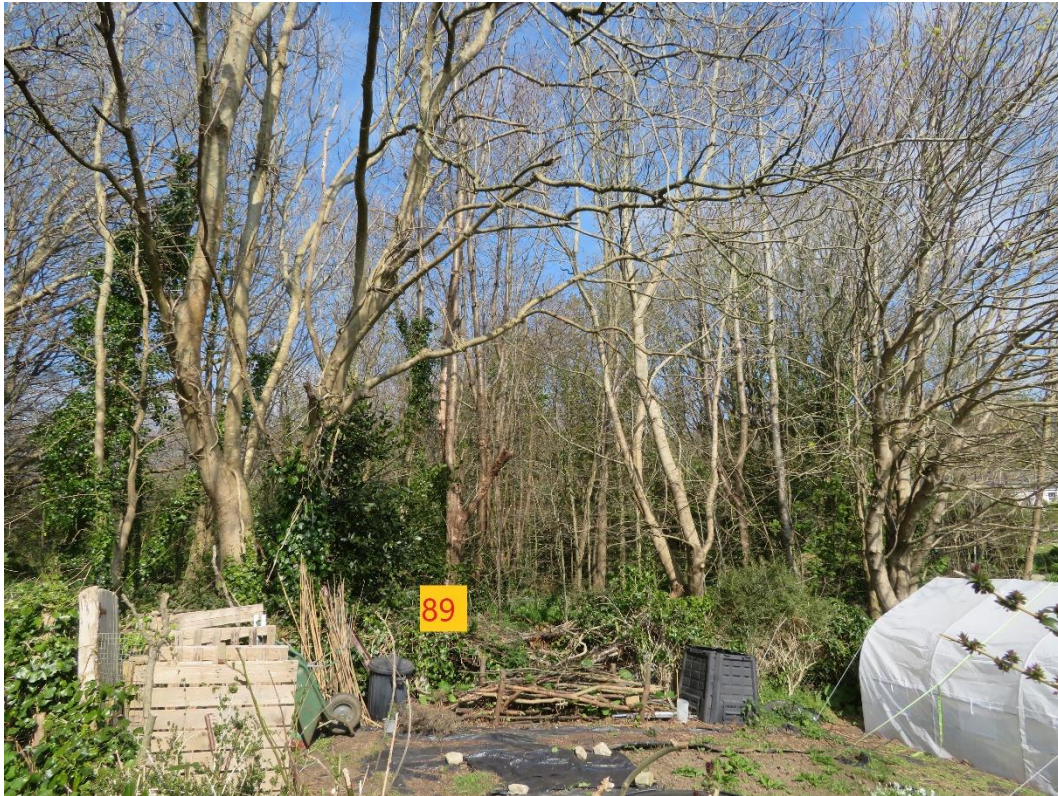
T89

Cherry with stem decay.
